BRANZ Type Test

FI 5466-TT ISSUE 2

**ISO 9705 FIRE TEST AND NZBC VERIFICATION METHOD C/VM2
APPENDIX A PERFORMANCE OF 1.2 MM POLYCARBONATE CLADDING**

PSP Limited
320 Rosedale Road
Albany
Auckland 0632
New Zealand

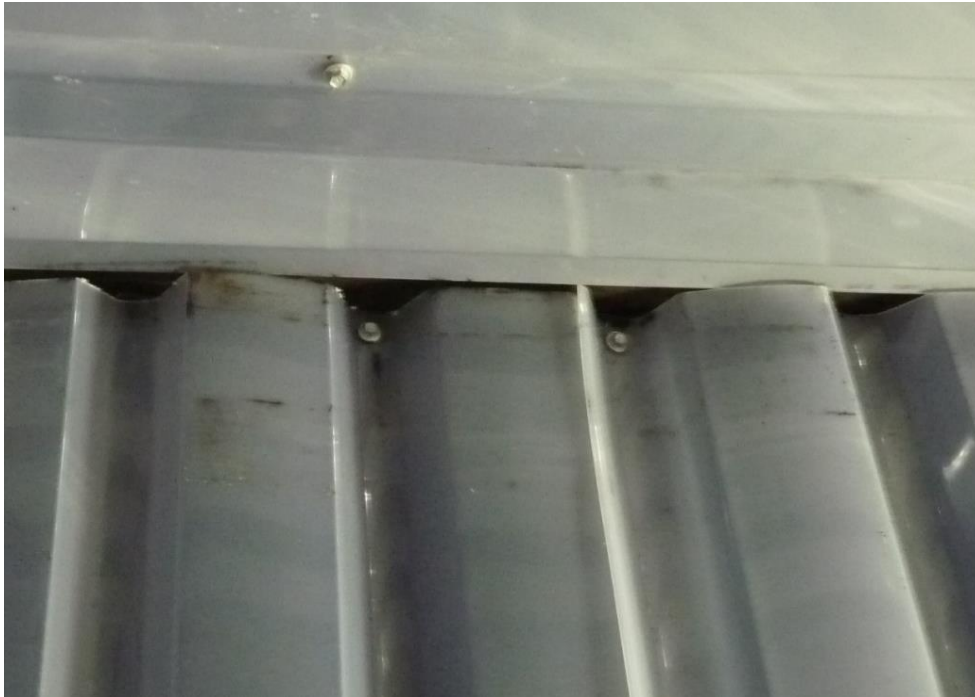
Figure 1: Installation detail

The product submitted by the client for testing was identified by the client as nominally 1.2 mm thick polycarbonate profile cladding with peaks 25 mm high at 150 mm pitch. A weighed sample had a unit weight of 1.46 kg/m². The outside surface is treated for UV protection. Figure 1 shows a detail of the roof and wall of the installed specimen.

A lightweight steel stud frame was installed against the three full walls and ceiling of the test room. Wall studs were nominally spaced at 600 mm between centres and ceiling battens at nominally 450 mm centres.

The walls of the test room were lined with nine sheets of the polycarbonate whereby the non-UV protected side was facing the inside of the room with the corrugations oriented vertically. The sheets were fixed with screws identified as; Fortress fasteners Class 4, Premium Plated, Hex W/F Supadrive W/NEO, 12g PLUS-13 x 55. Fixing was at the top, middle and bottom to the nogs/plates at nominal centres of 1200 mm where the peaks touched the framing typically at every second peak or 300 mm centres or less to secure joints between sheets.

Similarly, the three sheets fixed to the ceiling were fixed with the non-UV protected side facing downwards with the corrugations oriented in the longer 3600 mm direction. Sheets were screwed to the battens in no particular pattern at approximately 300 to 450 mm centres.

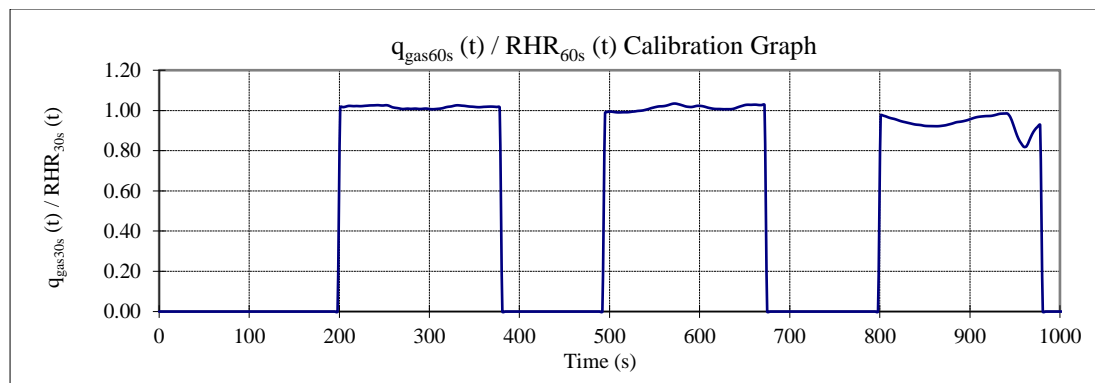
Figure 2: Calibration results for 100/300/100 kW burner output

Prior to the product test, a calibration was performed with the burner positioned directly beneath the hood and output adjusted to 0 kW for 2 minutes, then 100 kW for 5 minutes, then 300 kW for 5 minutes, then 100 kW for 5 minutes and then 0 kW for 3 minutes. Data was collected at 3 second intervals. The ratio of the average mass flow per unit area to mass flow per unit area in the centre of the exhaust duct that resulted in the least difference in the heat release rate calculated from the measured oxygen consumption, and that calculated from the metered gas input was determined. This calibration value ($k_i=0.757$) was then used in subsequent calculations of heat release rate for the actual product test.

At steady state conditions, the difference between the mean rate of heat release over 1 minute calculated from the measured oxygen consumption and that calculated from the metered gas input did not exceed $\pm 5\%$ for the first 100 kW and the 300 kW levels of heat output. The calibration results are shown in Figure 2.

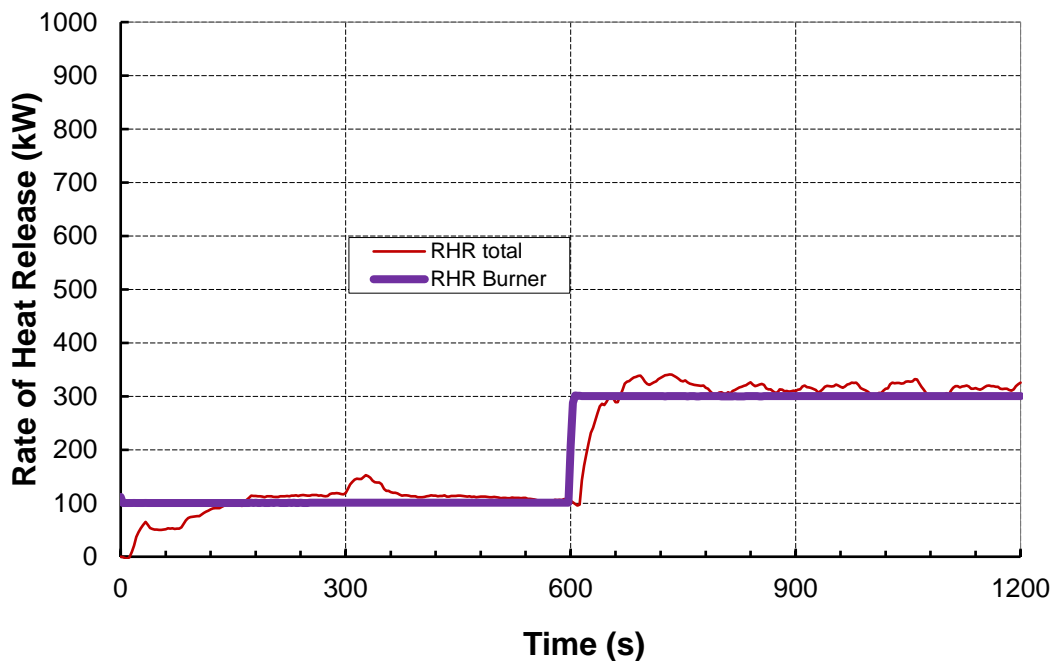
Figure 4: Rate of Heat Release

The total rate of heat release measured during the test and the contribution from the burner is shown in Figure 4. The peak rate of heat release did not exceed 1 MW during the test.

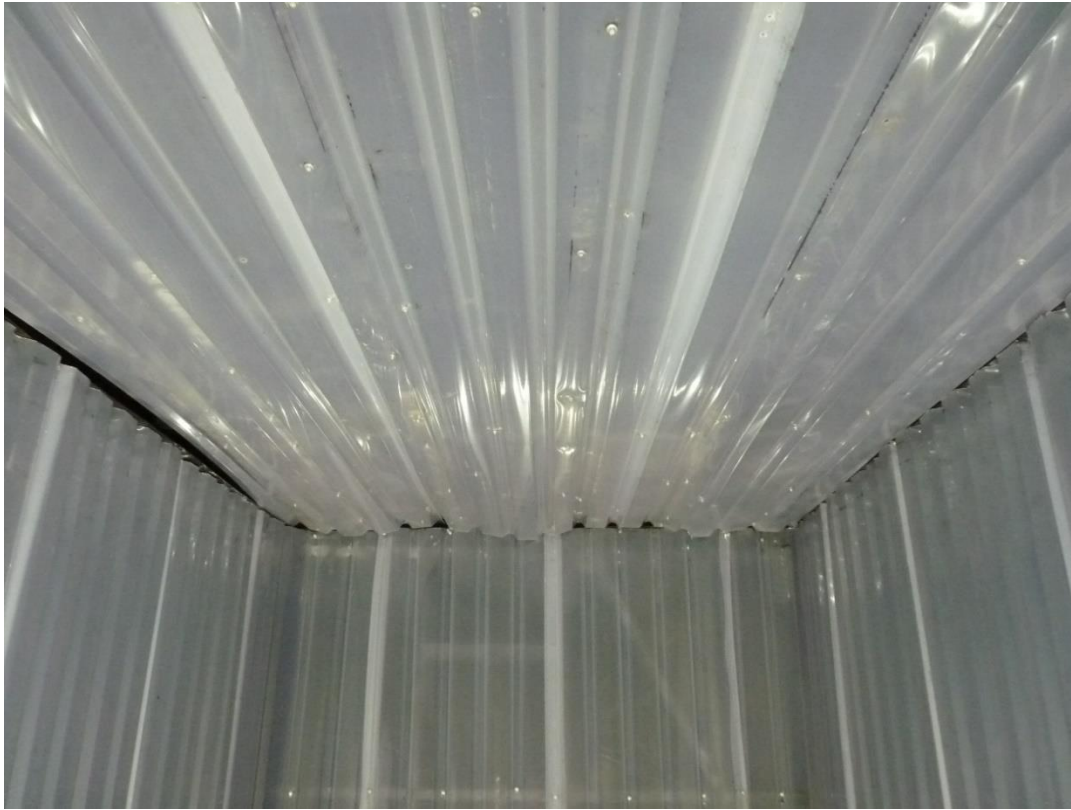
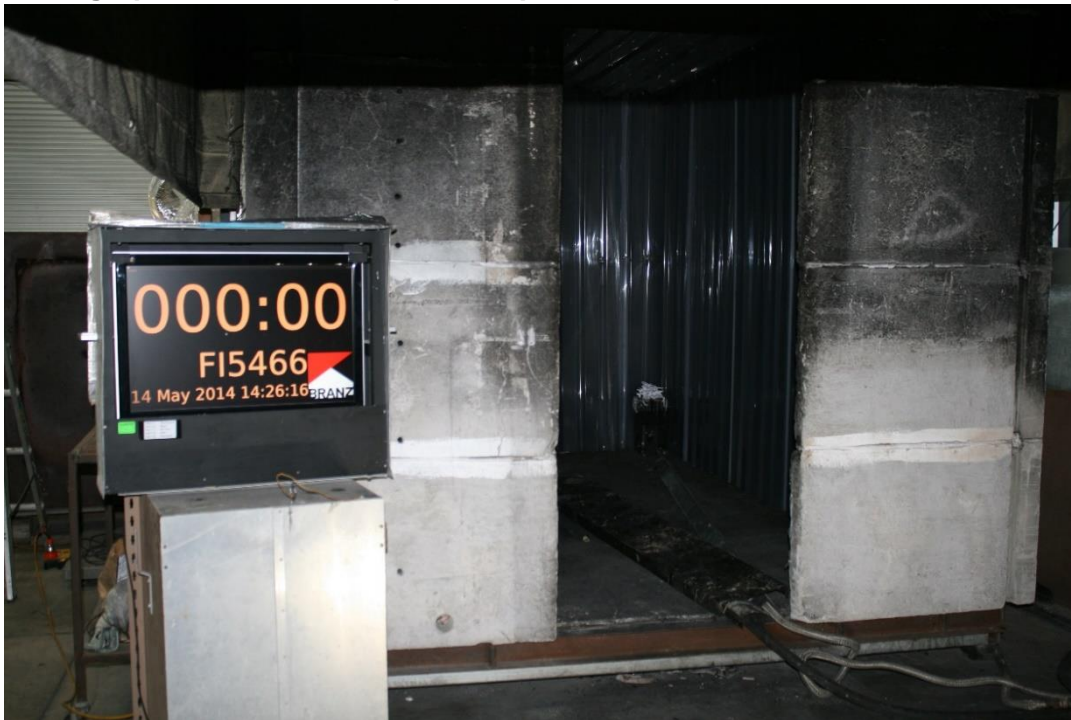
Photograph 1: Assembled specimen prior to test

Photograph 2: Assembled specimen prior to test

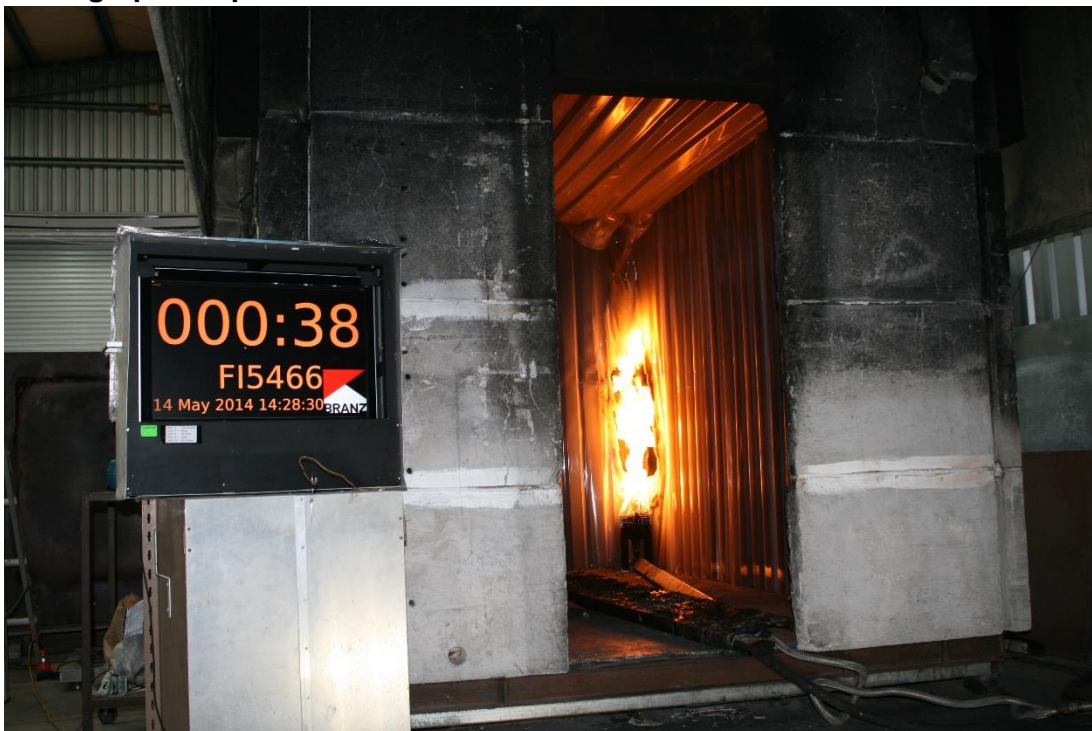
Photograph 4: Specimen at 38 seconds from start of test

Time Min:sec	Description
0:15	Some slight deformation of the polycarbonate sheeting above the burner.
0:40	Polycarbonate sheeting had melted away from the corner and was dripping downwards. Flaming was partly entrained through the melted gap and in behind the sheeting.

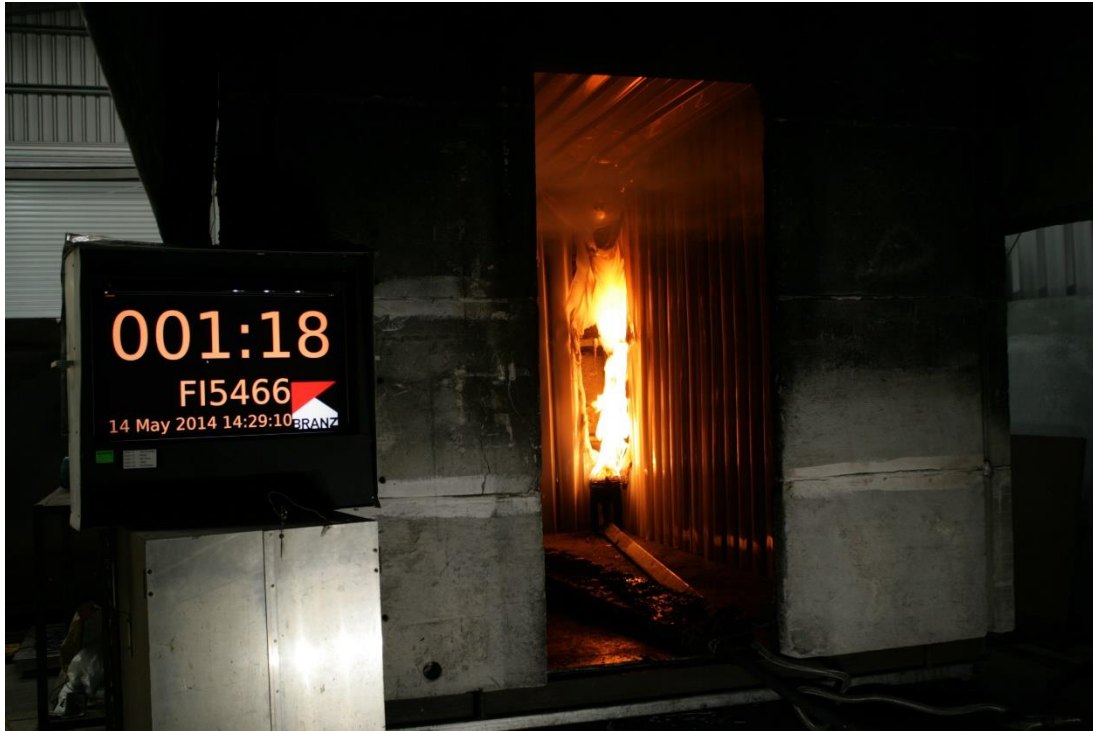
Photograph 5: Specimen at 78 seconds from start of test

1:20	Some drooping, buckling and falling down of the sheeting and general melting away from the burner flame was now evident accompanied by a build-up of smoke in the ceiling area above the door soffit.

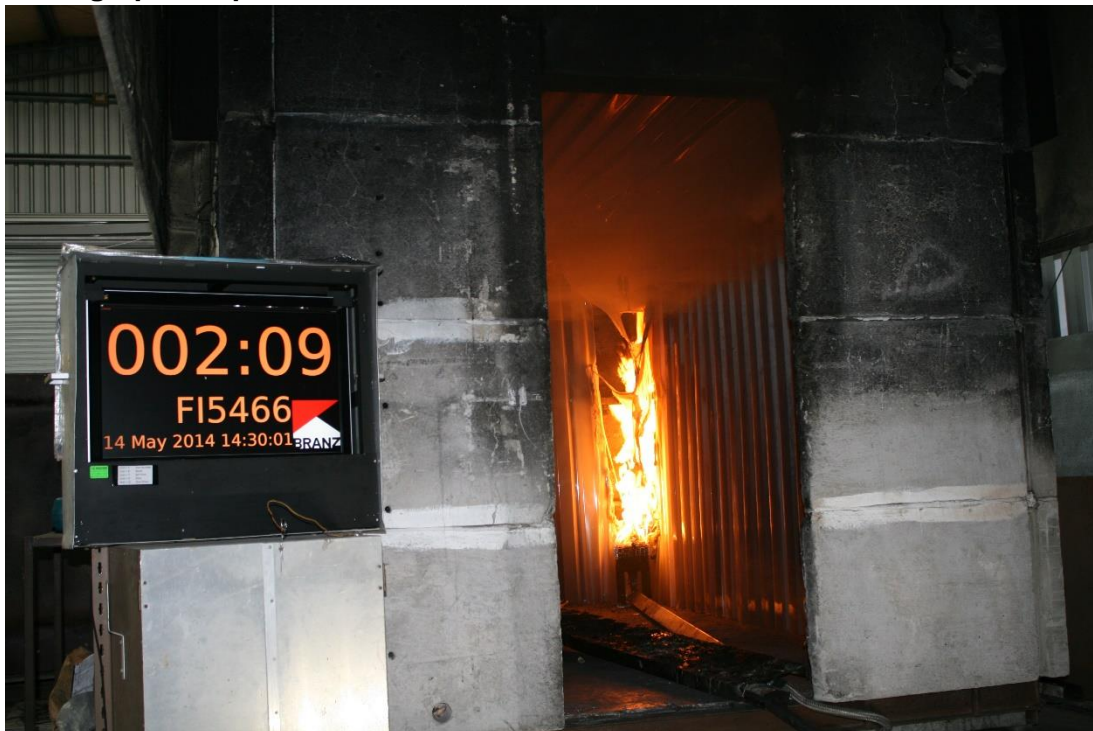
Photograph 6: Specimen at 129 seconds from start of test

1:44	Conditions in the room were now stable.
2:00	The smoke levels had built up further and there was some dipping of the sheeting into the burner.
3:00	Further build-up of smoke and the plastic had melted back marginally more from the burner corner and the sheet on the ceiling had become detached from the fixings and had softened and dropped about 1000 mm. Some minor ignition of the sheeting had established in the corner.

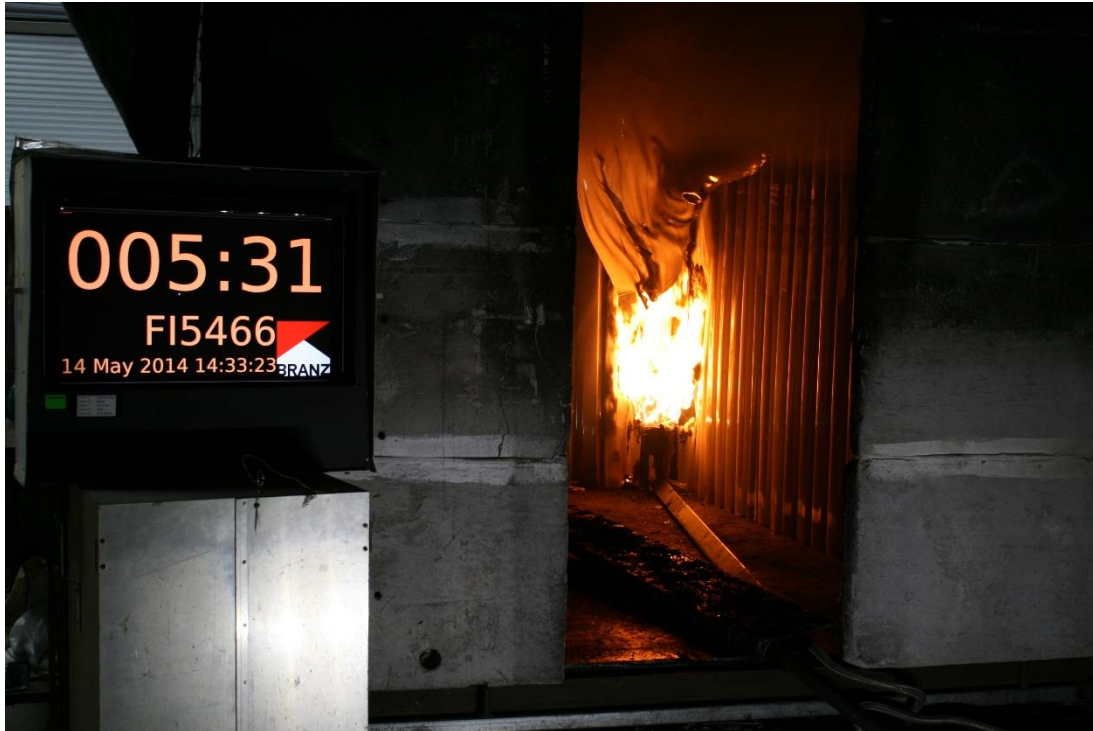
Photograph 7: Specimen at 331 seconds from start of test

6:30	Large portions of the ceiling had softened, pulled over the fixings and dropped, but no significant ignition had occurred, the smoke levels had diminished as the sheet had continued to soften and recede from the hotter regions of the burner flame.

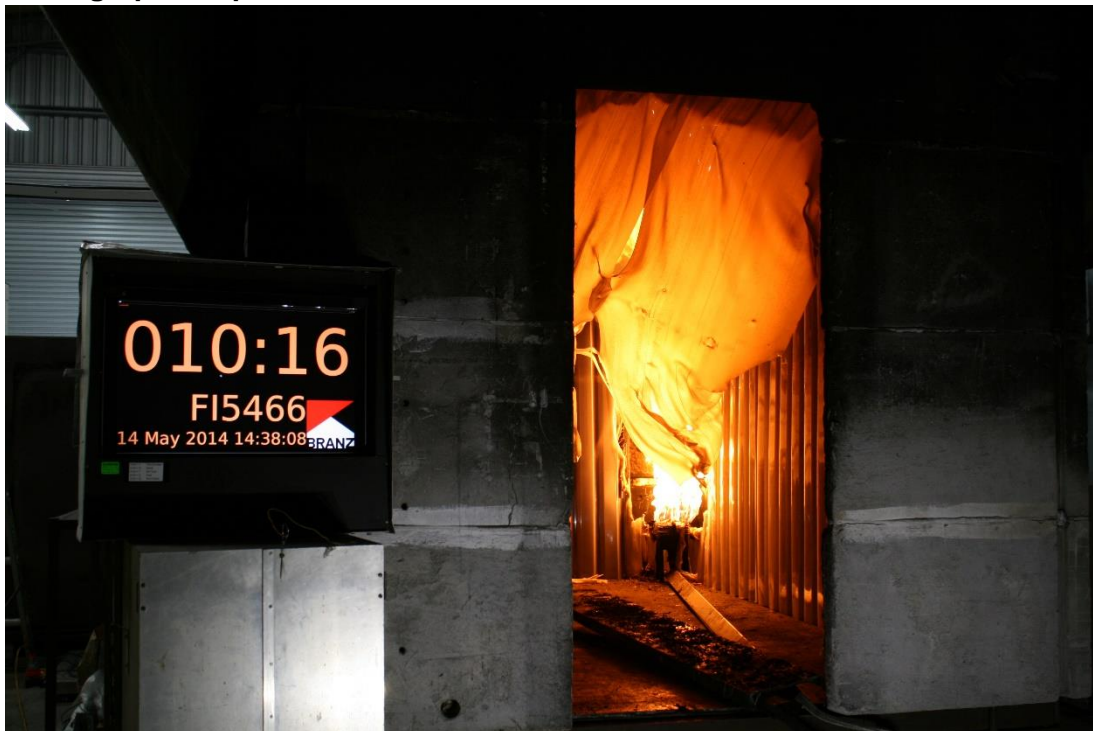
Photograph 8: Specimen at 616 seconds from start of test

9:30	The plastic sheeting had continued to peel off the ceiling but had not yet reached the floor.
10:00	Burner HRR increased to 300 kW.
10:20	The sheeting in the centre of the room had almost reached the floor. The sheeting in the corner across from the burner had started to droop as well.

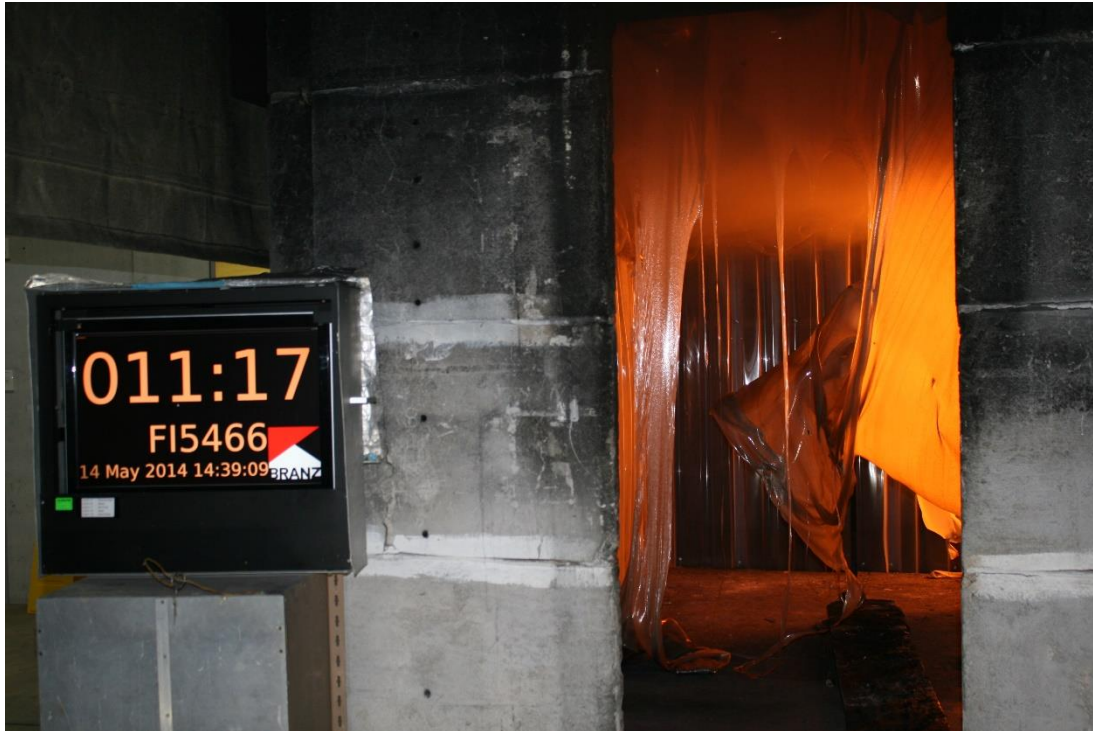
Photograph 9: Specimen at 677 seconds from start of test

11:00	A build-up of smoke in the ceiling above the door soffit was occurring again, accompanied with a resumed softening and dropping away of the sheeting.

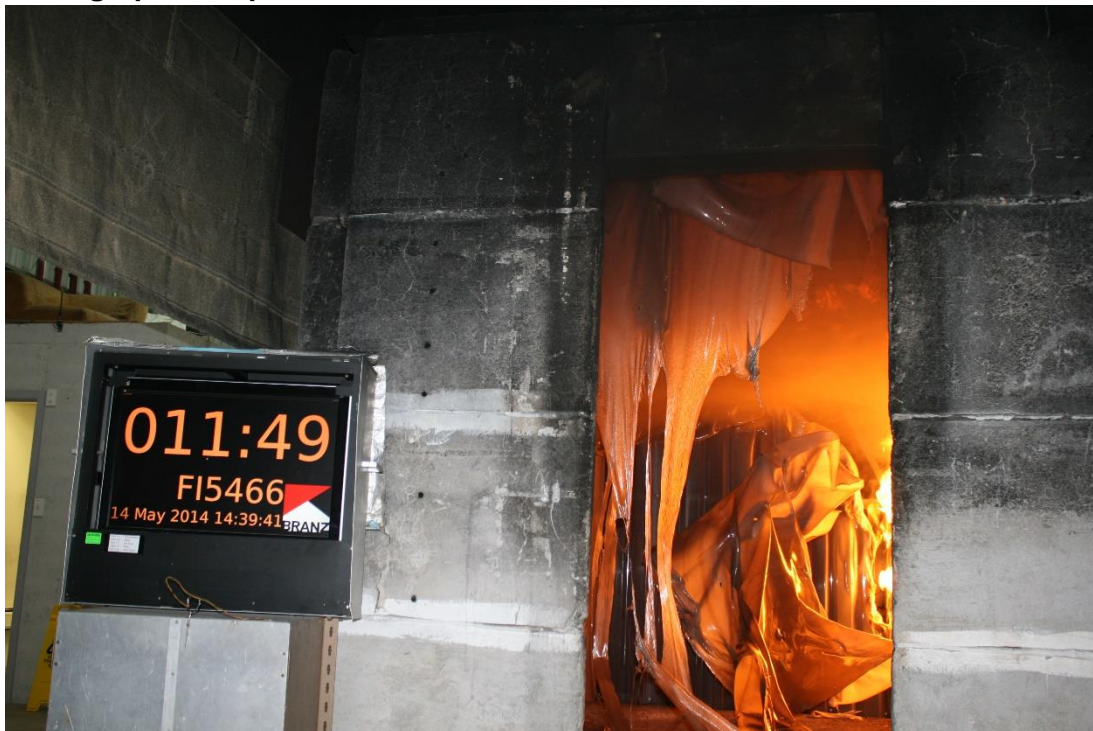
Photograph 10: Specimen at 709 seconds from start of test

11:15	The sheeting was now settling on the floor.
12:30	The sheeting on the walls in the heat affected zone coinciding with the accumulation of smoke had softened and was drooping down the walls as far as the hot/cooler layer interface indicating a clear demarcation line.

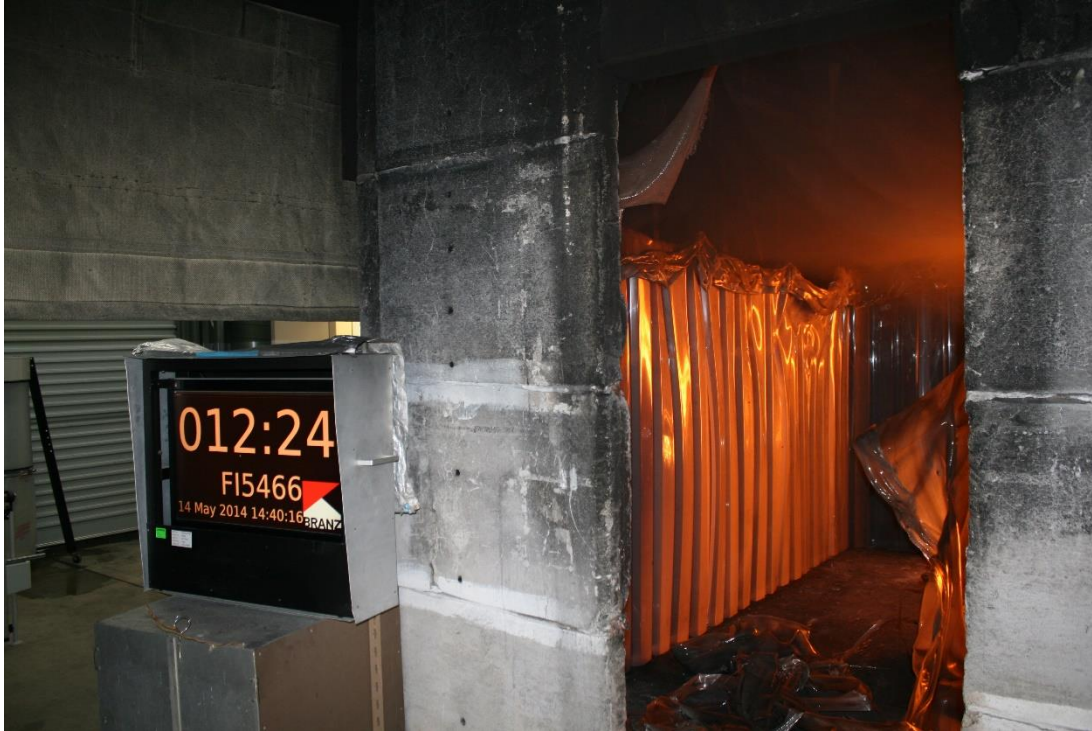
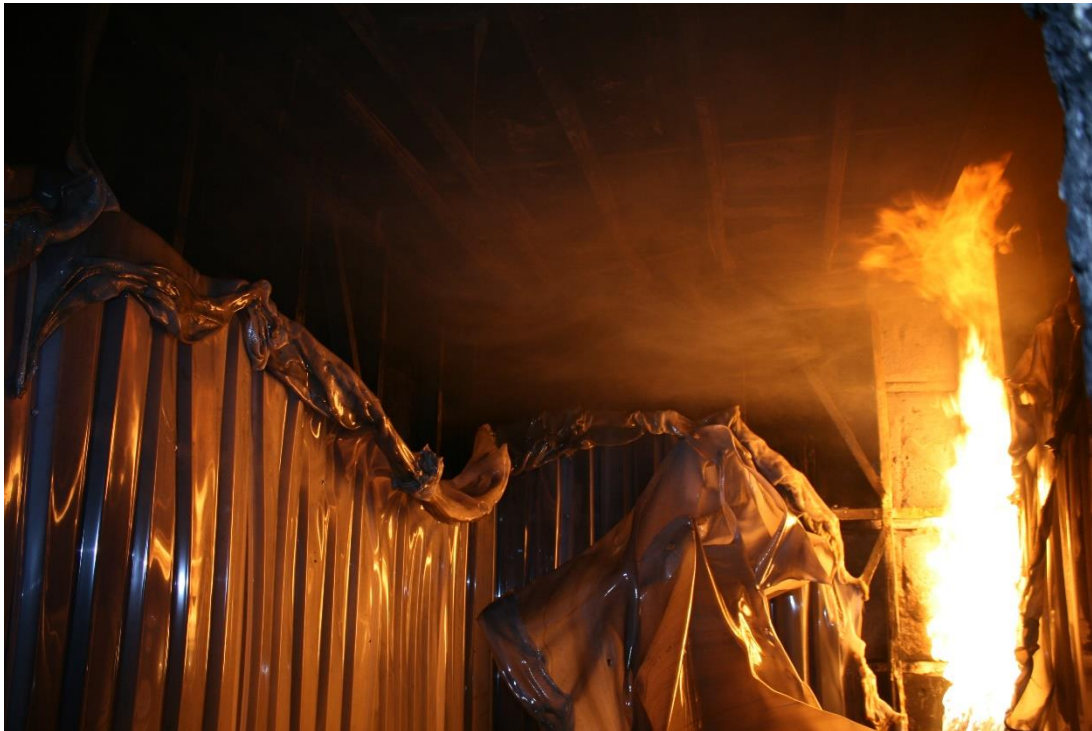
Photograph 11: Specimen at 744 seconds from start of test

Photograph 12: Specimen at 772 seconds from start of test

13:30	The entire ceiling had become detached and the drooping on the walls had reached mid height on the back wall and halfway along the side walls and then only to two thirds height closer to the door end.

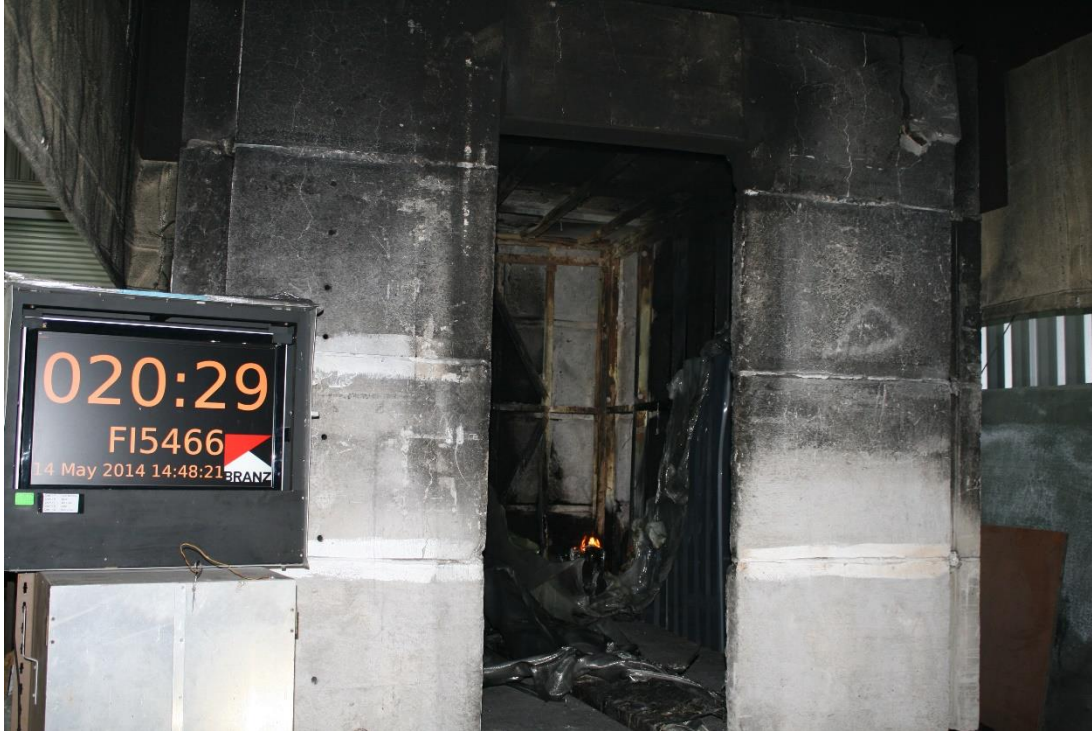
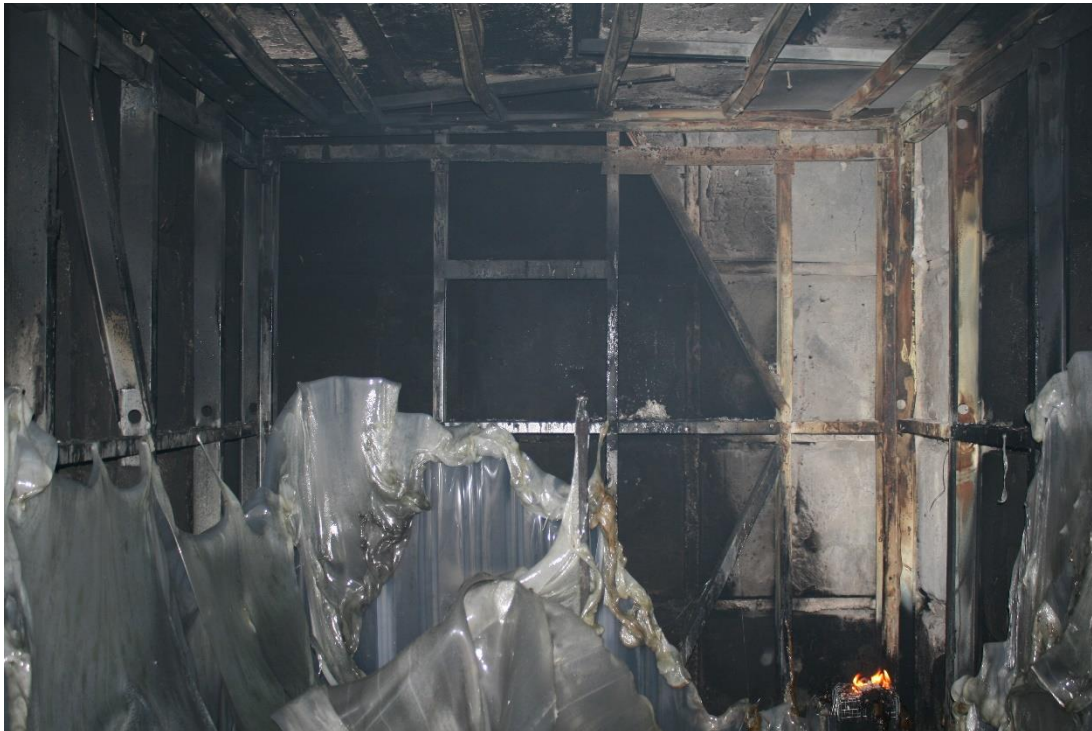
Photograph 13: Specimen after end of test

Photograph 14: Specimen after end of test

19:30	Sheeting has drooped down to floor level in the immediate burner corner, but still at mid height on the side walls.
