TEST REPORT

Bushfire resistance test of an external wall system to BAL-A40 in accordance with AS1530.8.1-2007

38031900.1

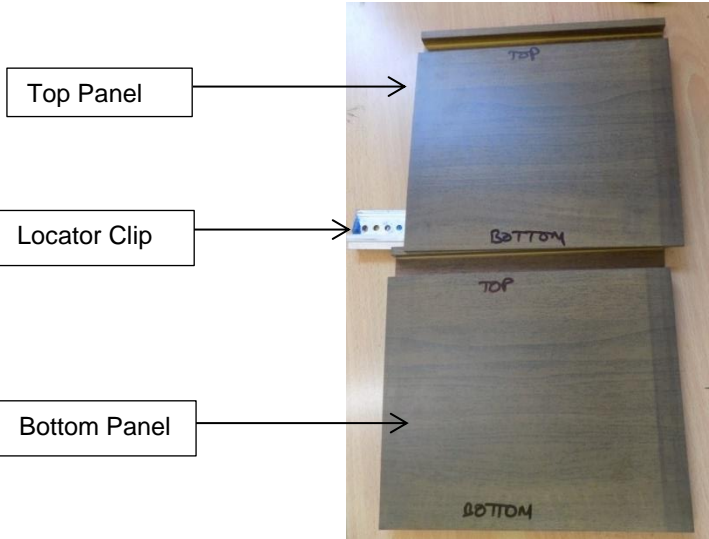
No.	Item	Description
Substrate		
1	Product	Ullrich Aluminium - Ulltraclad® Shadoline Weatherboard
	Material	Aluminium
	Size	1500mm wide × 205mm high × 15.0mm deep with 1.5mm thick aluminium
	Linear Mass Density	1.3 kg/m (measured)
	Location/ Fixing	<p>The panels were installed horizontally from the bottom up on the exposed side of the timber frame (item 13) with a layer of sarking (item 8) in between. A starting channel (item 2) was used at the bottom perimeter while a locator clip (item 5) was installed in between the panels.</p> <div style="text-align: center;">

</div> <p>A top channel (item 4) was installed at the top edge of the panels along the perimeter. The panels were screwed to the studs of the timber frame (item 13) with Square Head Square Drive 8g × 50mm long Coarse Thread screws. See Figure A1.4 for illustration.</p>
Support System		
2	Item Name	Window Flashing
	Product	<p>Aluminium extrusion</p>

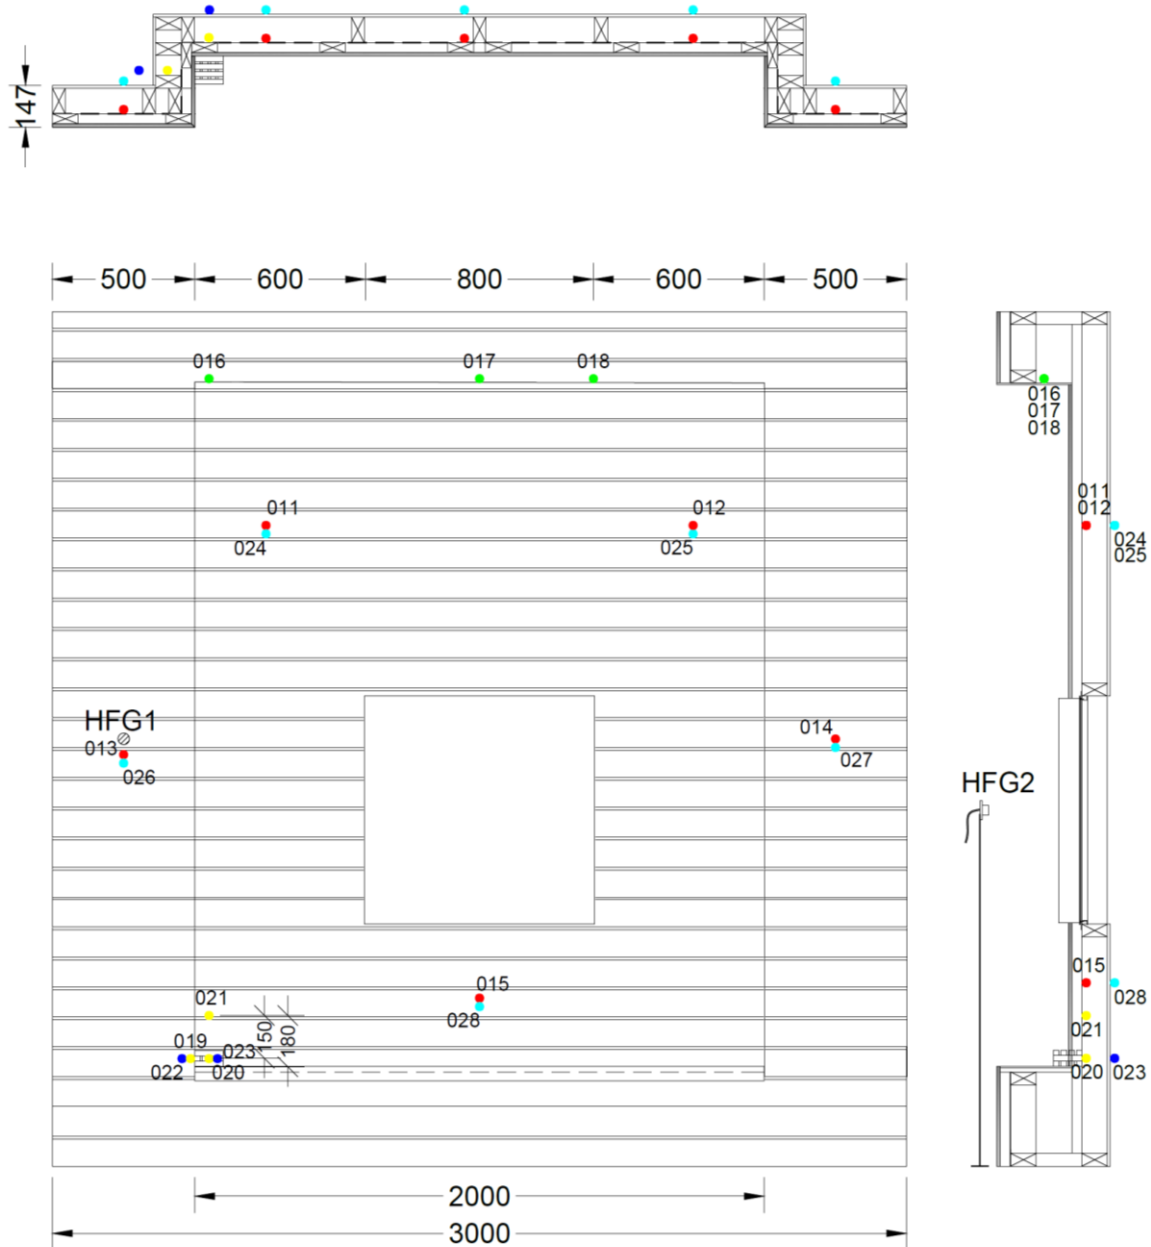
Figure A4.1: Thermocouple locations on wall system

Note: The crib was located in the south internal corner of the recess to the exposed side

The Heat Flux Gauge positions are shown in Figure A4.1 in Appendix 4.

The instrumentation was positioned in accordance with the requirements of AS1530.8.1-2007, Clause 16.3 as summarised below.

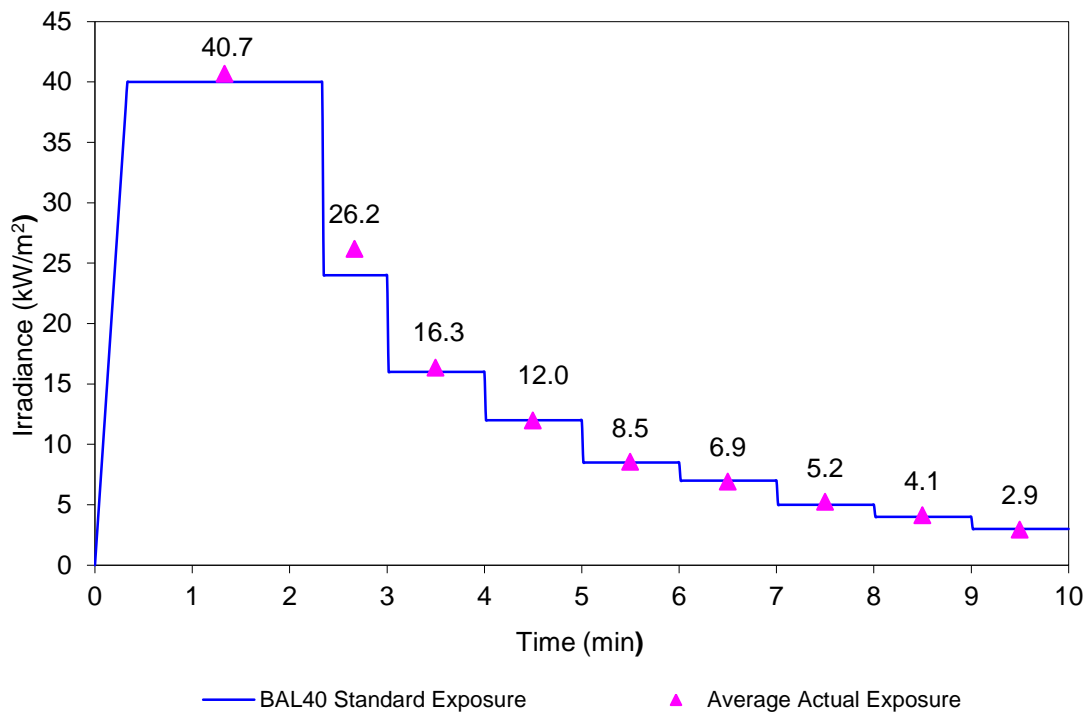
Figure A5.1: Averaged irradiance levels during the test to the external facade

Less than 0.4 kW/m² heat flux radiation was received by the heat flux gauge positioned centrally to the front of the specimen, 250mm from the wall during the time period 20 to 60 minutes.

Heat flux measurements are provided in Figure A5.1 in Appendix 5.

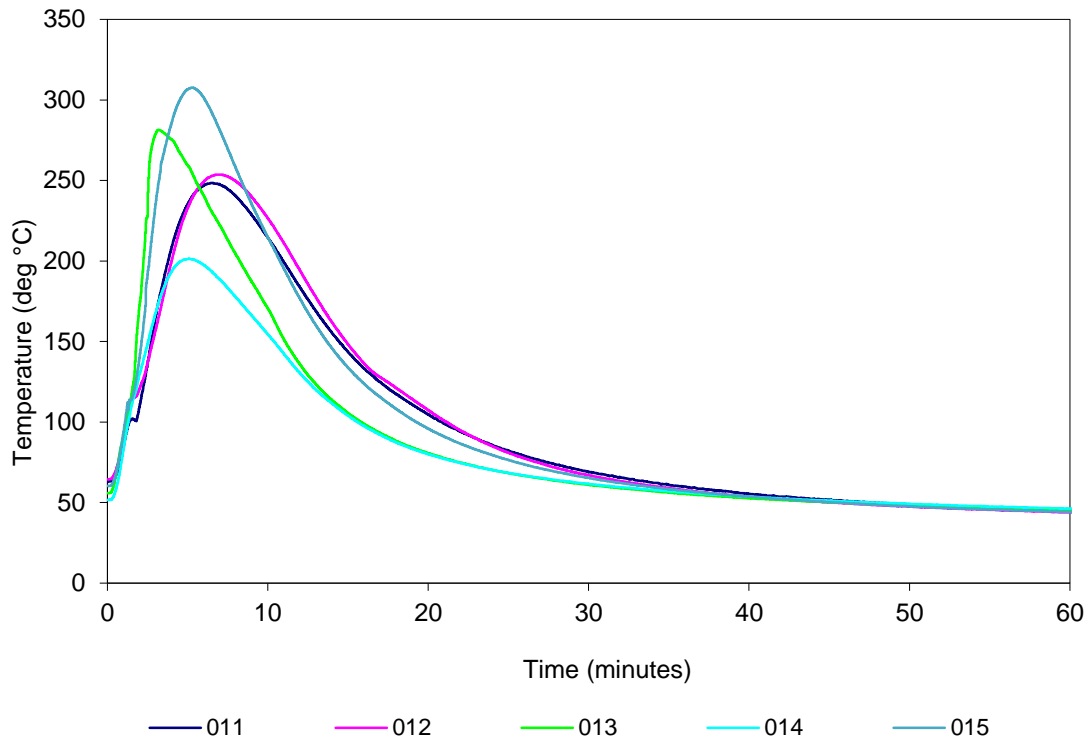
Figure A5.2: Specimen temperatures. Temperatures vs. time, Internal quarter points

Specimen temperature data is provided in A 5.3 and Table A5.1 in Appendix 5.

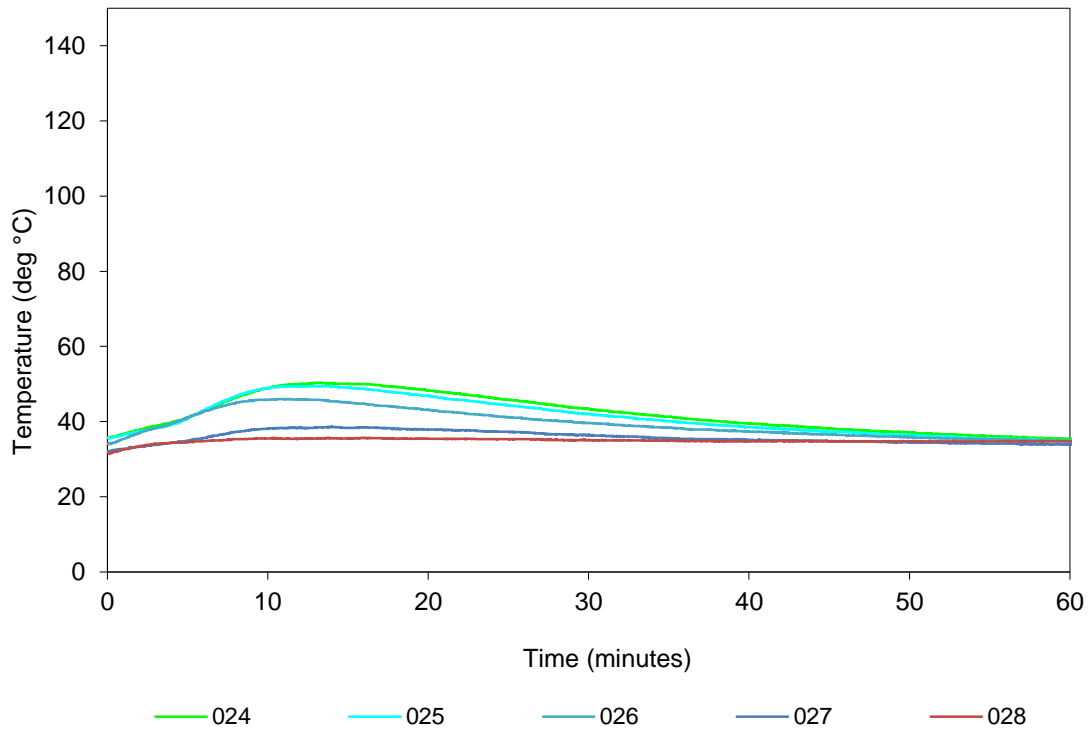
Figure A5.3: Specimen temperatures. Temperatures vs. time, Unexposed quarter points

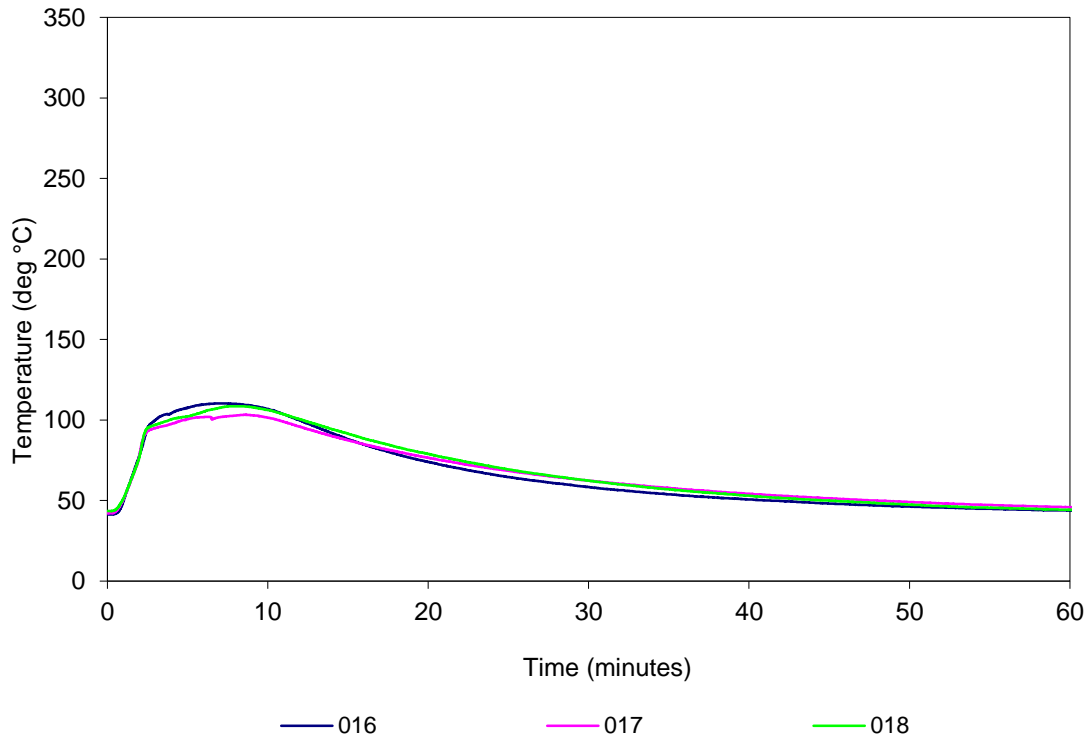
Figure A5.4: Specimen temperatures. Temperatures vs. time, Eave mean and maximum

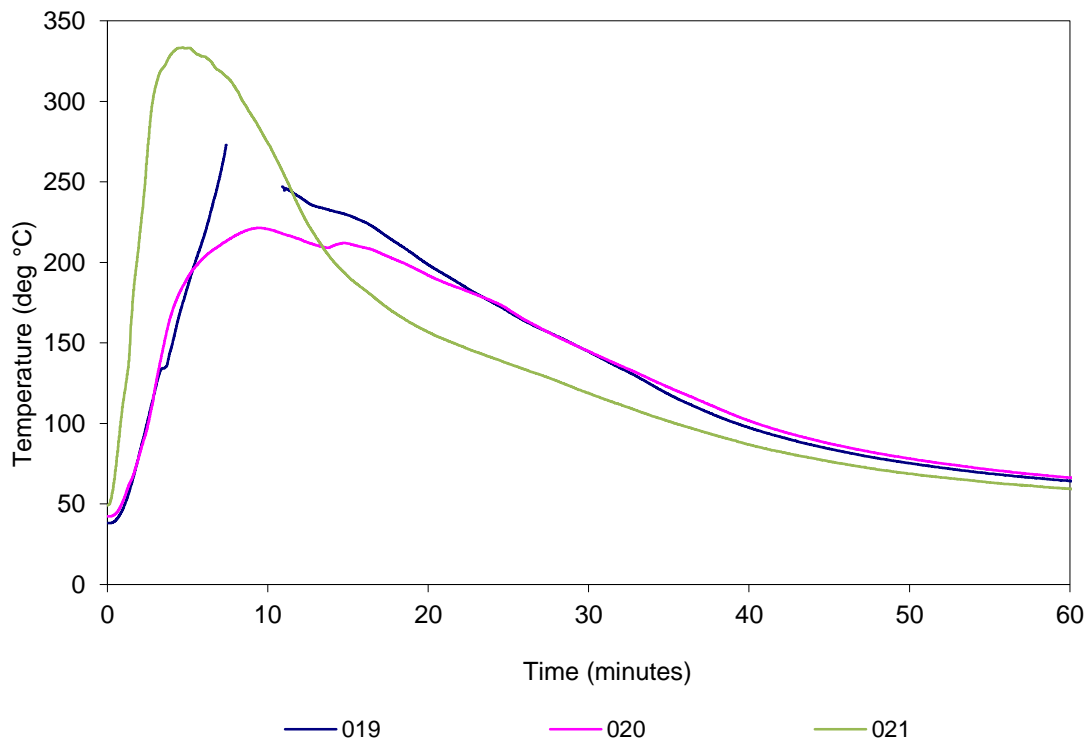
Figure A5.5: Specimen temperatures. Temperatures vs. time, Internal around crib
TC 019 had disconnected between 7-11 minutes hence data has been omitted for that duration.

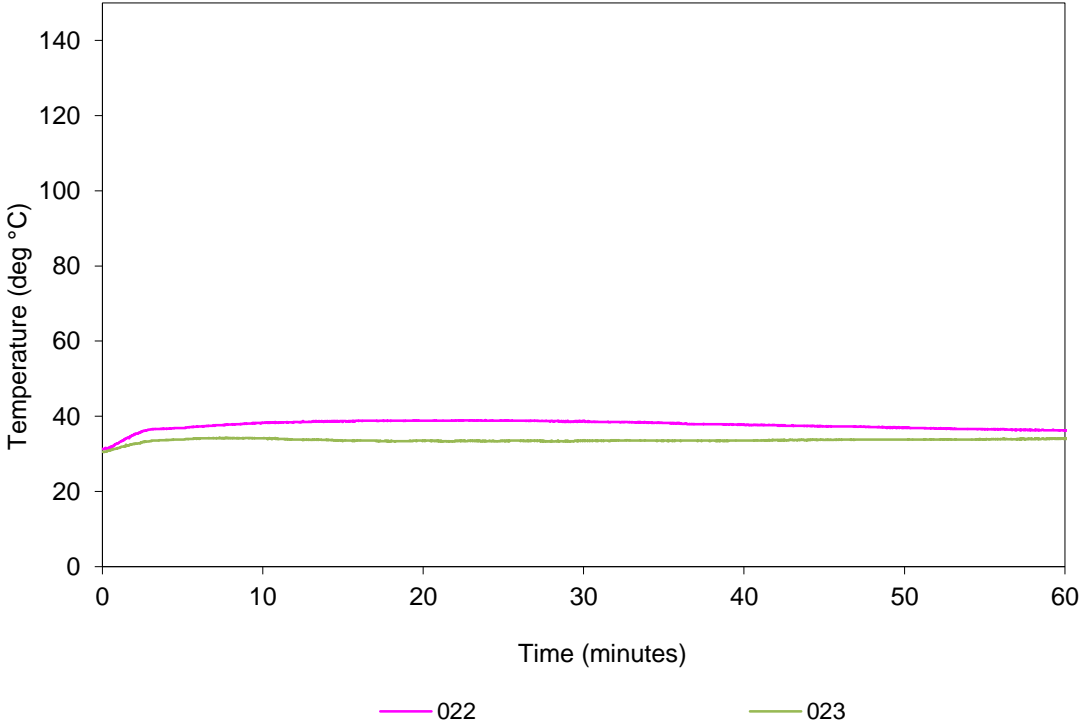
Figure A5.6: Specimen temperatures. Temperatures vs. time, Unexposed around crib

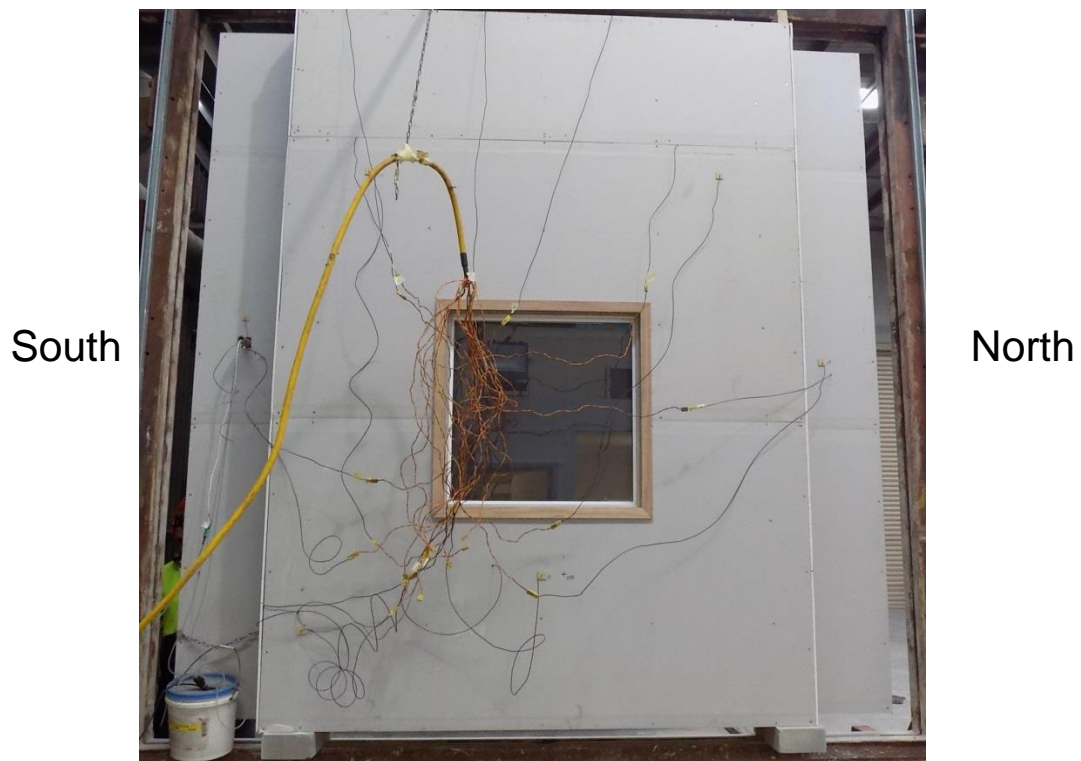
Figure A6.1: Unexposed face of specimen before commencement of the fire-resistance test

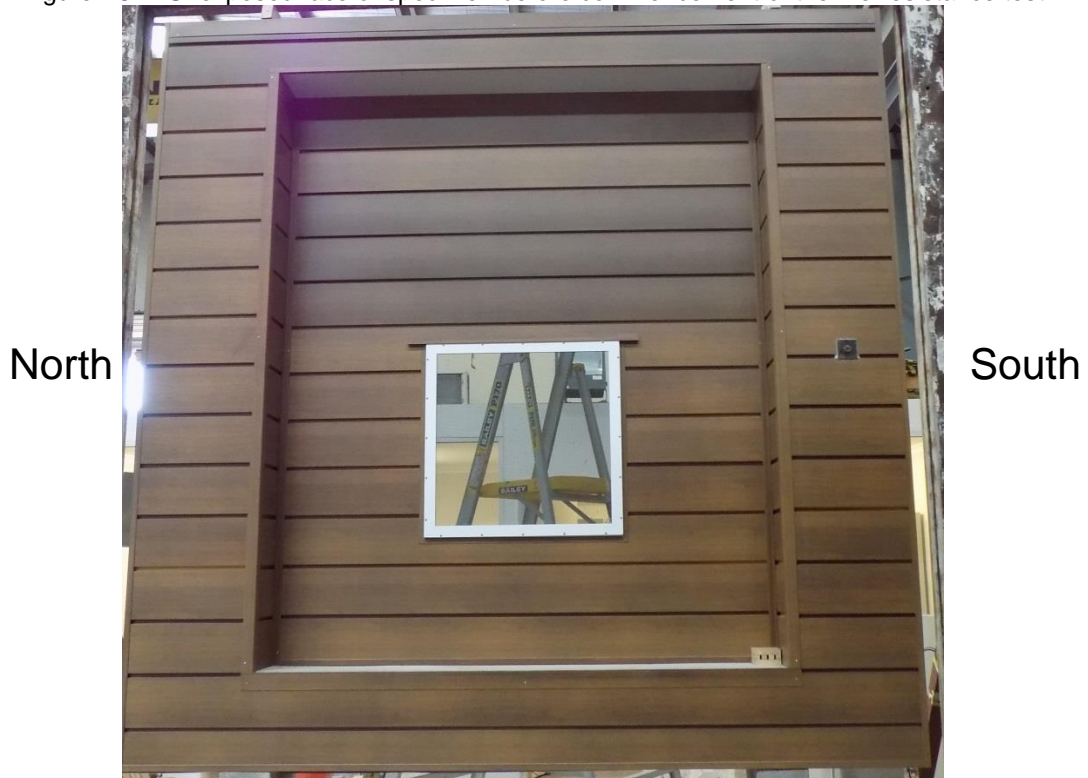
Figure A6.2: Exposed face of specimen before commencement of the fire-resistance test

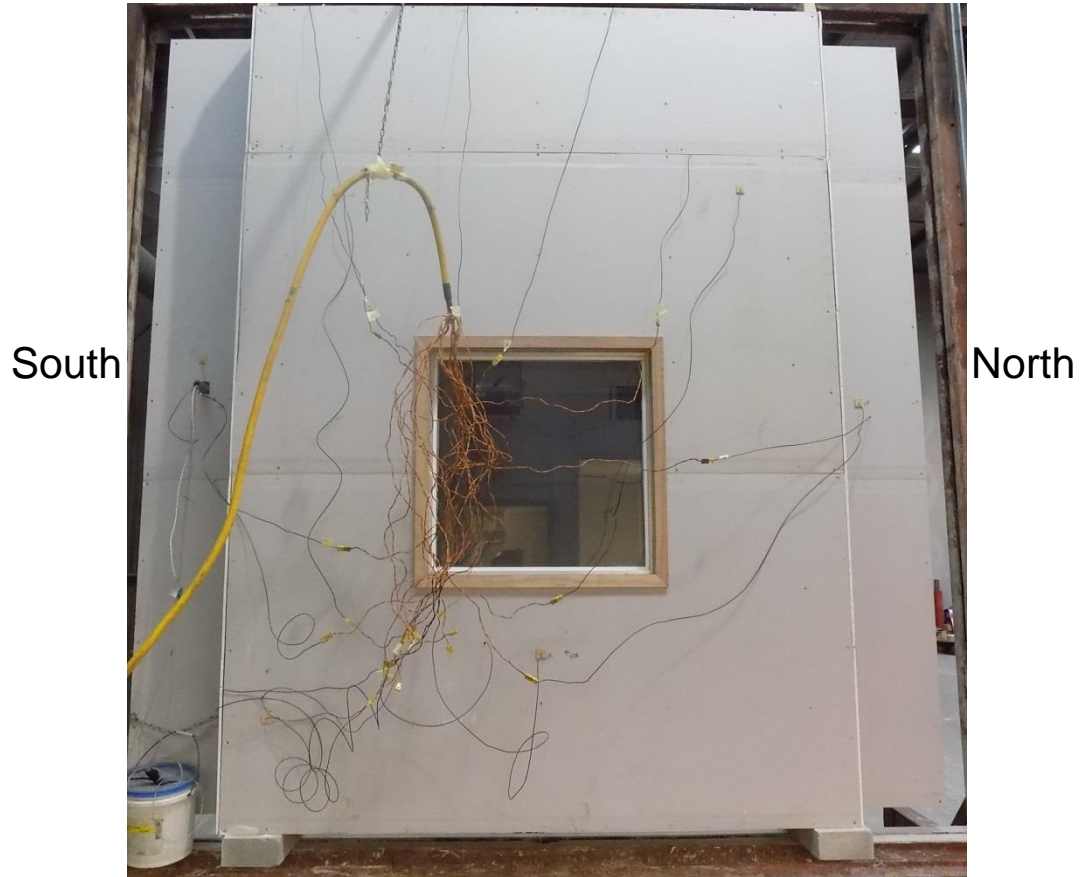
Figure A6.3: Unexposed face of specimen at the end of the test

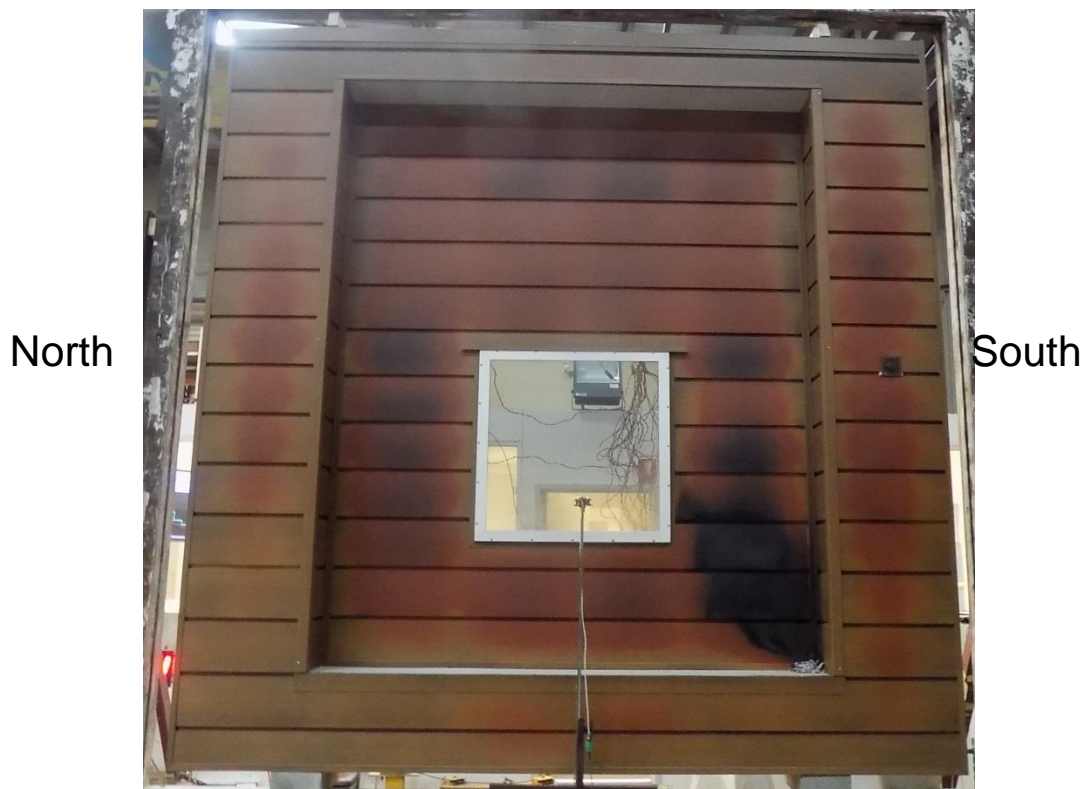
Figure A6.4: Exposed face of specimen at the end of the test
