ST0758/1 Rev. 1

Serviceability racking of the Ezpanel cavity wall system

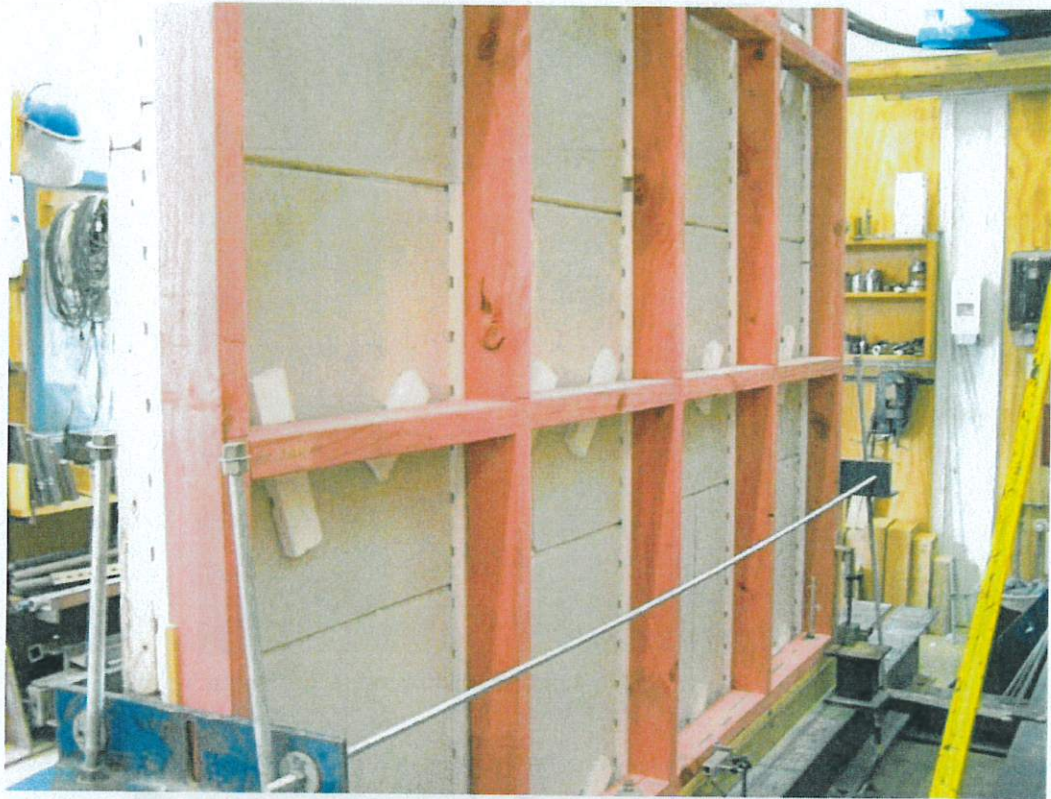
Figure 2. Back face of wall construction

The nominally 2.4 m x 2.4 m test specimen was made by the client to the details shown in Figure 1 as prepared by the BRANZ Appraisal section. The exterior wall cladding system includes a vented cavity through the use of battens fixed to the framing as shown in Figure 2.

Polystyrene cavity battens, of cross section 55 x 20 mm, were fixed to the front face of the studs and the top plate. 150 mm lengths of these battens were placed as spacers at approximately 45° to the vertical at 300 mm centres along each nog and the bottom plate as shown in Figure 2.

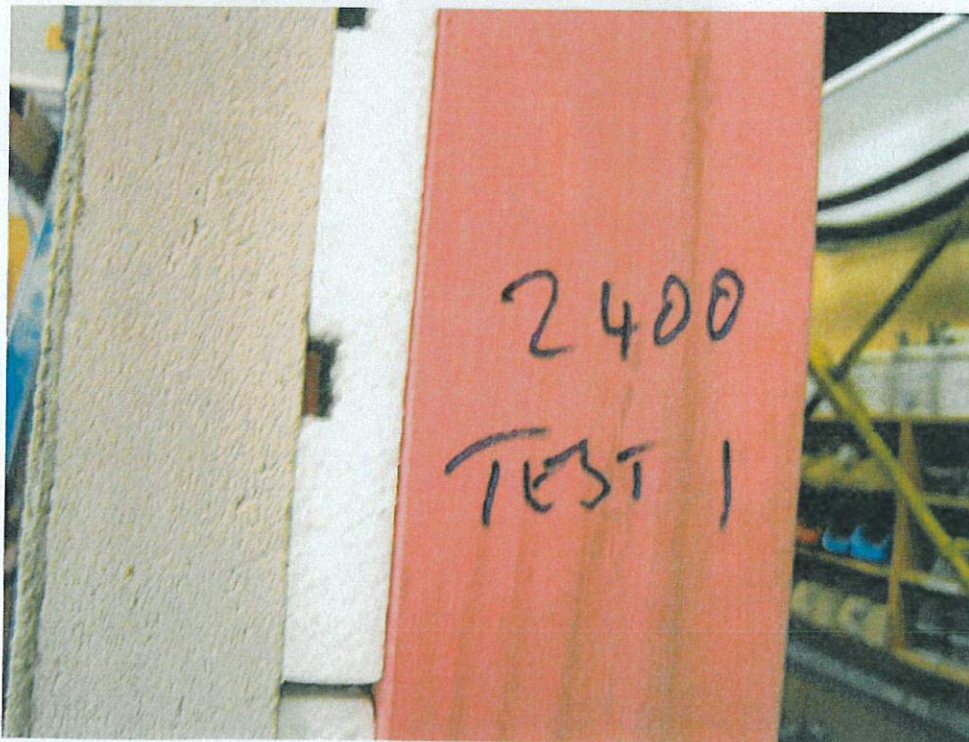
Figure 3. Cross section of wall construction

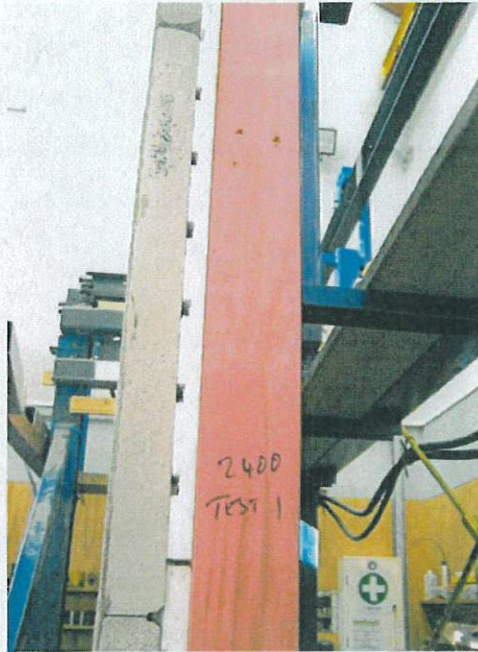
Figure 4. cross section on larger scale

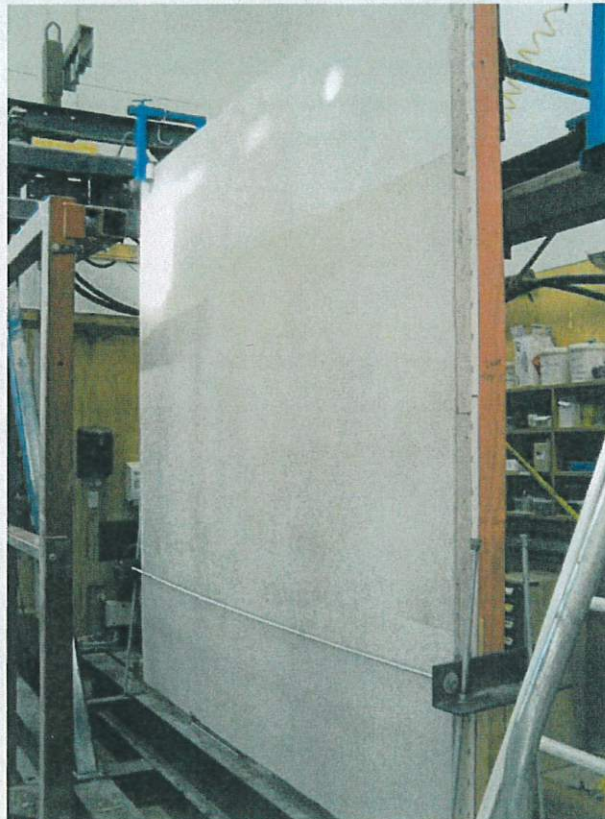
Figure 5. General view of test specimen
