FIRE PERFORMANCE EVALUATION OF A 4-MM THICK POLYETHYLENE-BASED CORE SANDWICH PANEL WITH ALUMINUM SKINS (MATERIAL ID: fr405 TRADE NAME: ALPOLIC/fr), IN ACCORDANCE WITH ISO 9705:1993, "FIRE TESTS—FULL-SCALE ROOM TEST FOR SURFACE PRODUCTS"

FINAL REPORT

SwRI Project No. 01-2208-021
April 1999

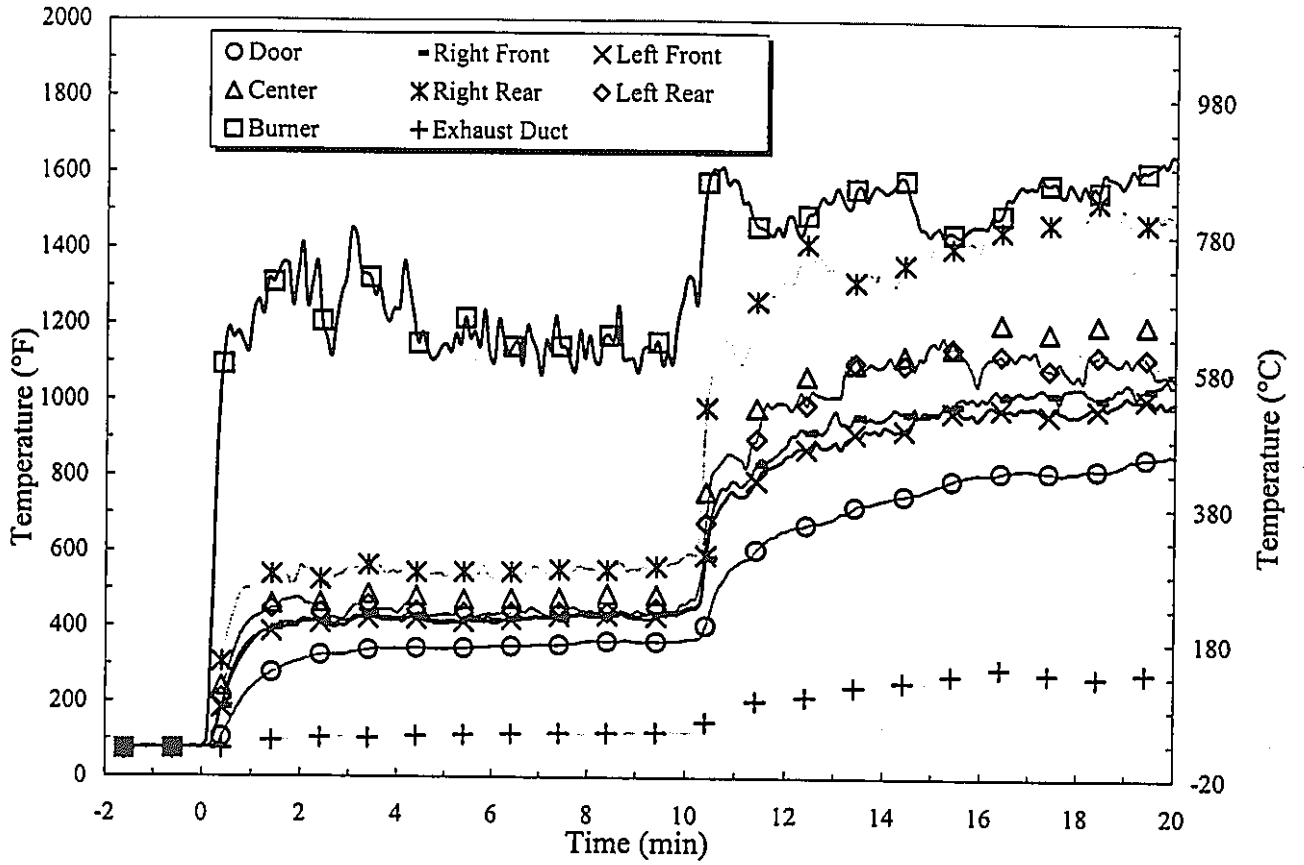
Figure B.3 Room Temperatures vs. Time

The instrumentation prescribed by ISO 9705 was supplemented with seven thermocouples to measure gas temperatures in the ceiling and in the doorway. The hot junctions of six of the supplemental thermocouples were located at approximately 4 in. (100 mm) below the ceiling of the test room, above the burner, in the center of the ceiling, and at the four quadrants of the ceiling. The ceiling thermocouple locations are identified as Southeast (front right), Southwest (front left), *etc.*, with the burner thermocouple in the left rear corner close to the Northwest thermocouple. The seventh room thermocouple was located in the doorway, so that its hot junction was at 4 in. (100 mm) below the soffit along the centerline of the doorway.

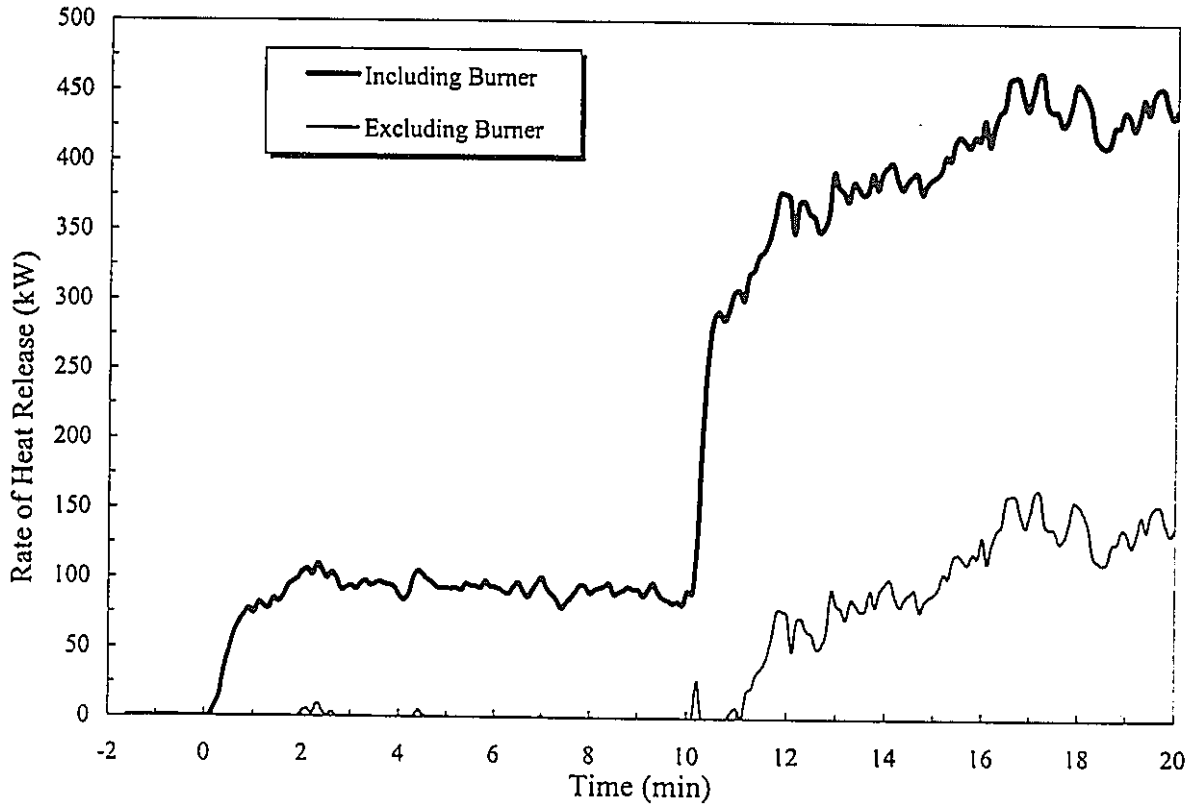
Figure B.4 Rate of Heat Release vs. Time

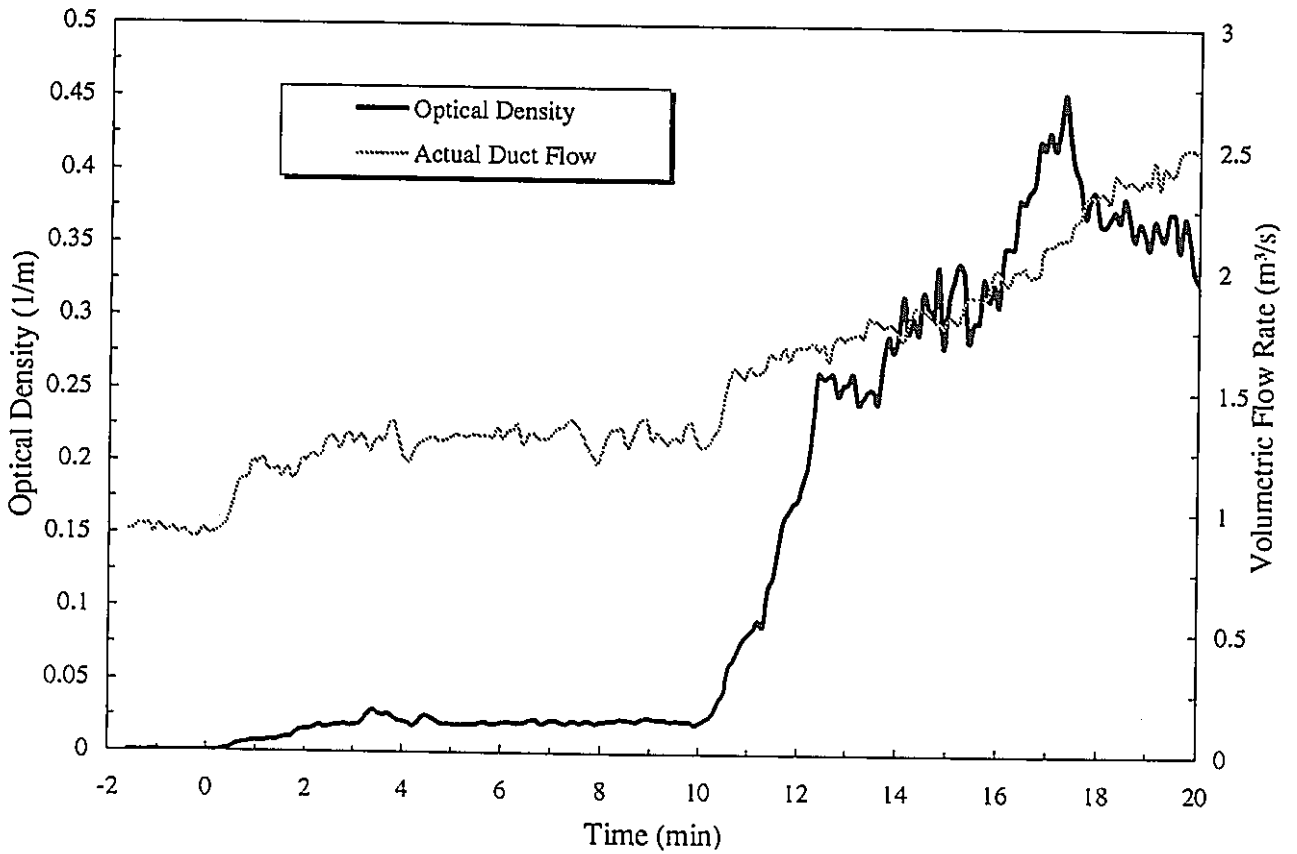
Figure B.8 Optical Density with Volumetric Flow Rate vs. Time

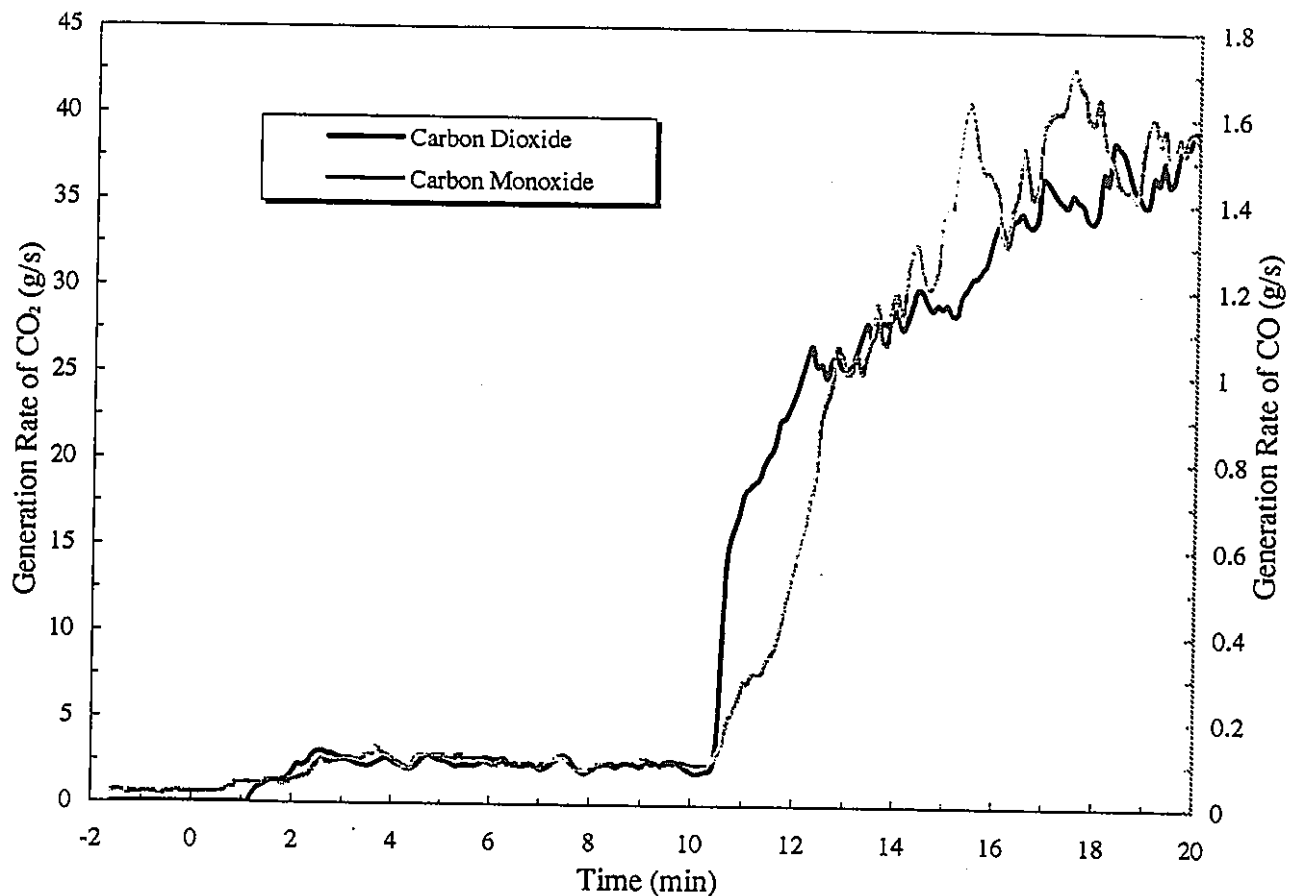
Figure B.9 Generation Rates of CO₂ and CO vs. Time

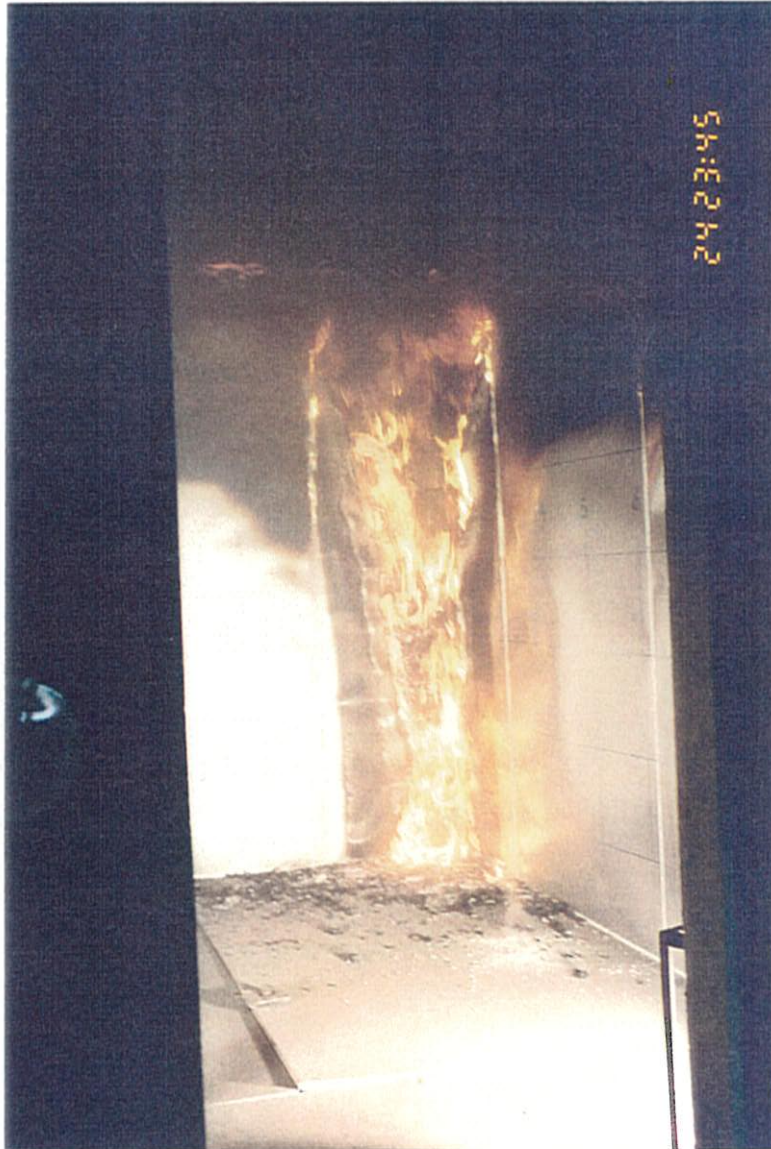
Figure C-2. Burner Corner Section at the End of 300-kW Exposure.

Upon completion of the 20-min fire exposure, damage to the room interior was confined to the burner corner and the upper edges of the aluminum panels near the ceiling. Melt away in the burner corner measured approximately .25 m wide along both walls starting at the top of the burner and spreading over to 0.6 m at the 2.1-m level and from there spreading horizontally over to 1.2 m along both walls. Directly in the burner corner the second layer of aluminum skin had burned/melted away exposing the calcium silicate substrate. The remaining surface of the panels showed blistered paint with warping and buckling of the test panels.

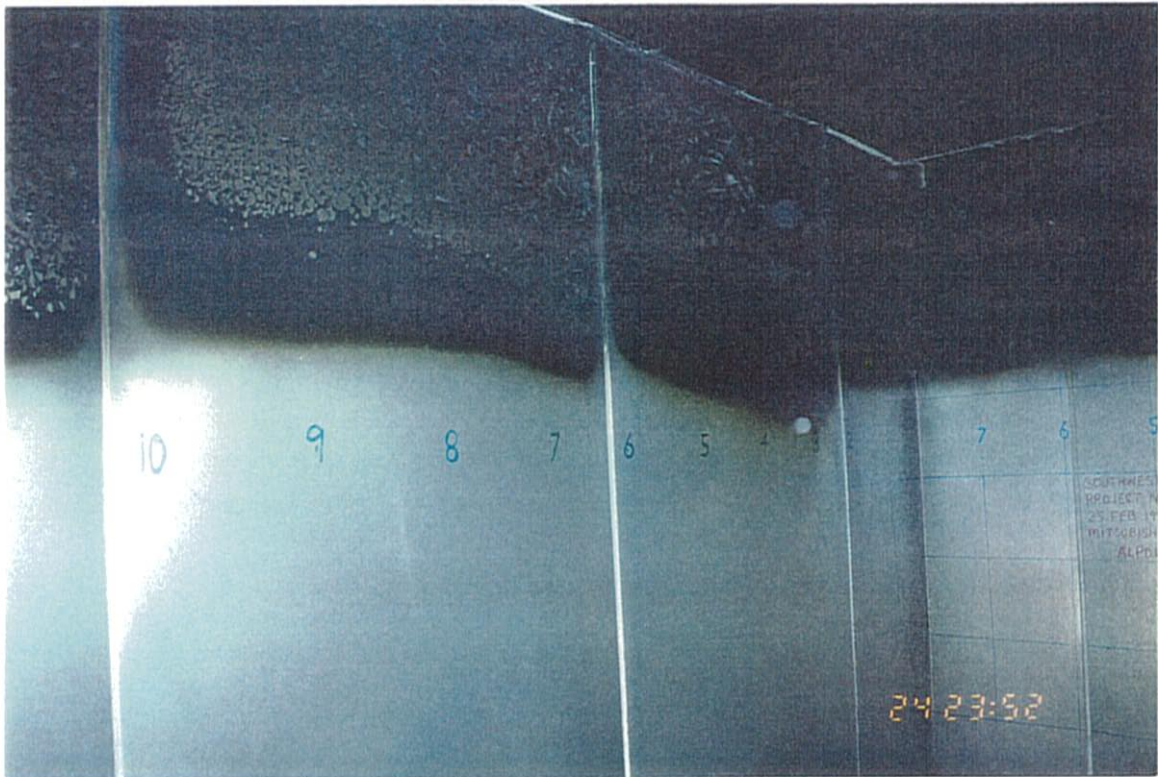
Figure C-3. Room Interior Showing Left and Back Walls. Note blistering and flaking of paint coating on aluminum skin.
