Insulated Panels
New Zealand

Fire Performance of Insulated Panels

New Zealand, July 2023 edition

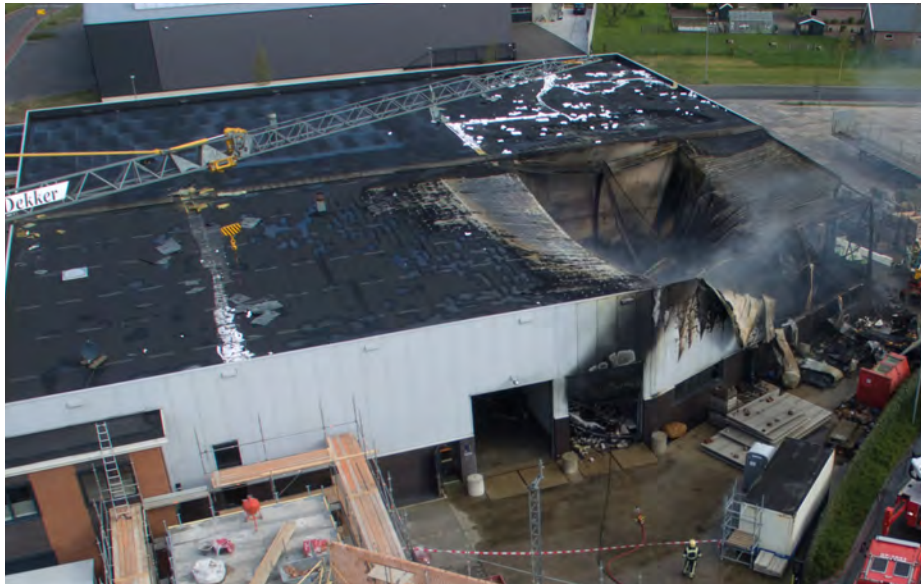
Aerial view of the damage showing structural collapse of the army surplus warehouse.

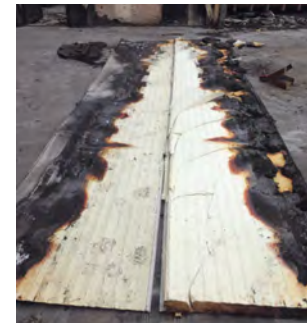
Panel at junction with steel stripped off demonstrating charring of PIR core but no evidence of fire spread.

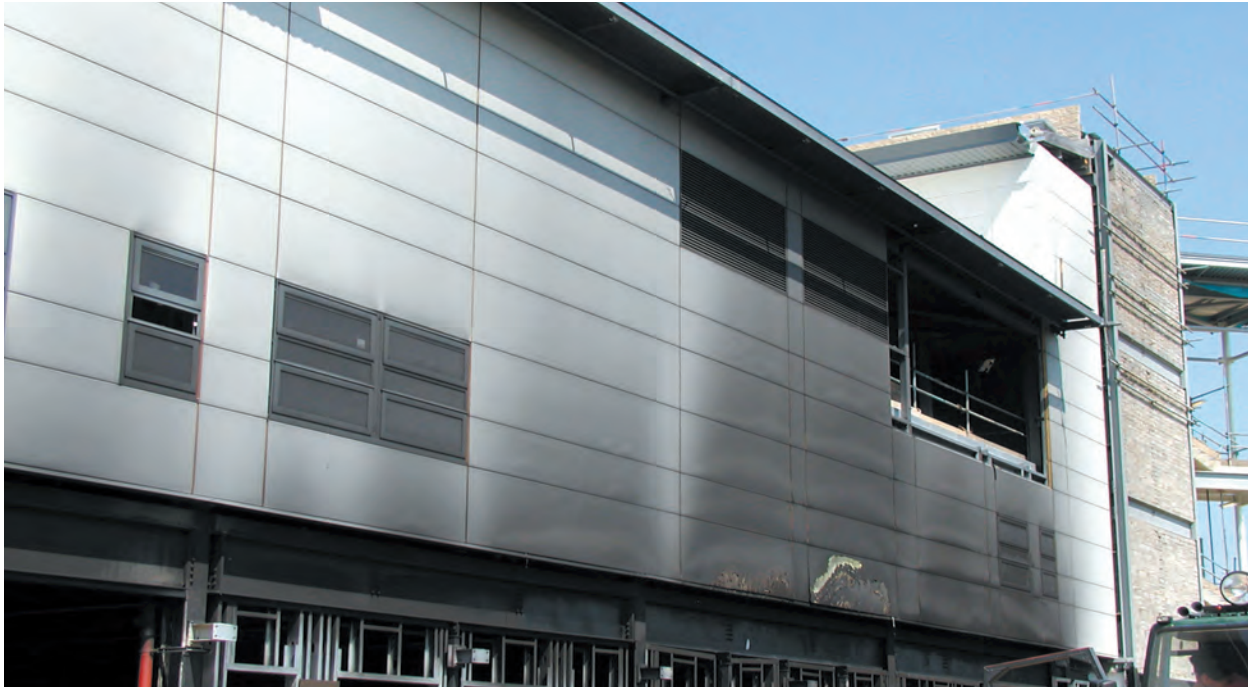
The main image above shows where the insulated cladding panels on the external face of the building had been attacked by flames.

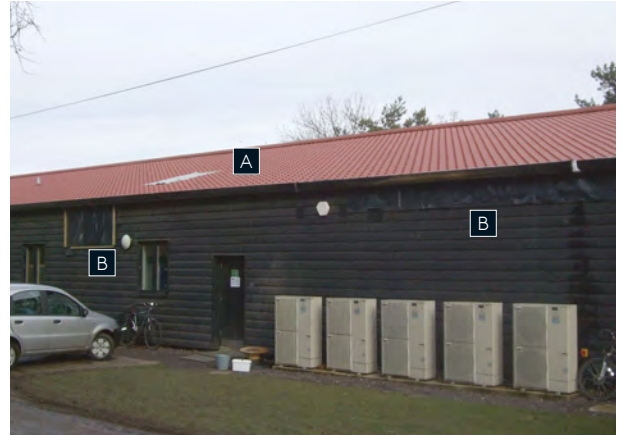
A: Vent cut in roof by fire service. B: Vents cut in wall by fire service.

On locating the area of the fire the attending fire service cut a hole through the roof construction directly above the fire and in the location of the damage shown in the above image to ventilate the area.

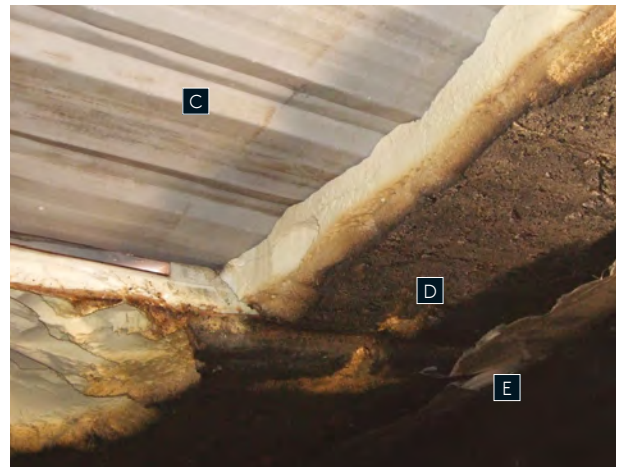
C: Temporary roof covering over hole in roof.

D: PIR core showing delaminated lower surface and extent of through-thickness charring.

E: Cut edge of lower steel skin of sandwich panel.

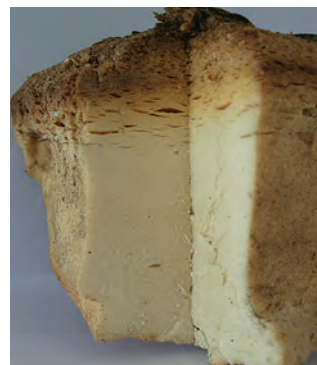
Insurer Approved PIR core sample showing extent of through-thickness charring at Suffolk Food Hall.

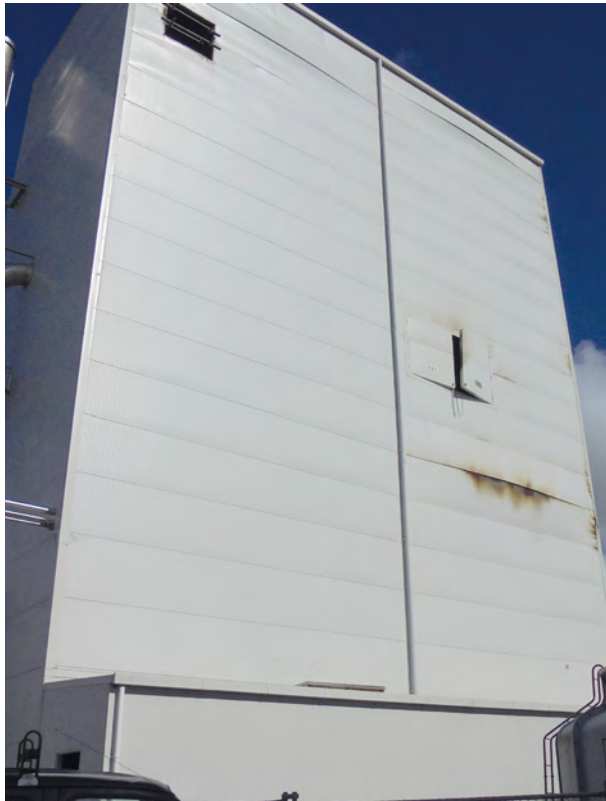
Milk powder drying tower showing external fire damage to panels (explosion doors opened manually after fire).

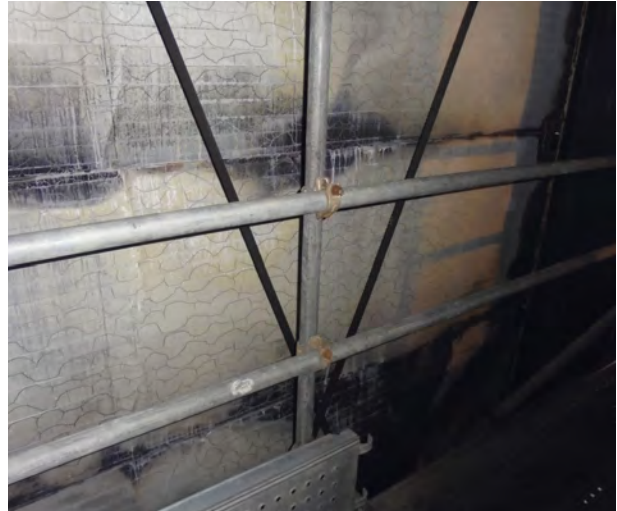
Panels exposed to fire internally.

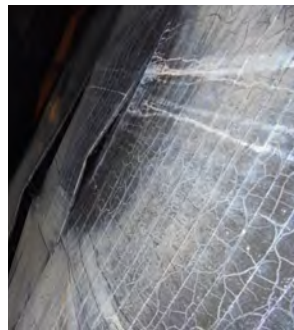
Fire penetration into panel core, material charred but still in place, no void.

Findings concluded that a fire emanated in the region of the base of the milk powder drying cyclone and the fluid bed dryer. It is in this area, approximately mid-way up the tower, that there is extensive fire damage to the plant and structure and where the cladding had been exposed to direct flame impingement. Here the fire has penetrated into the PIR core causing the material to surface char.

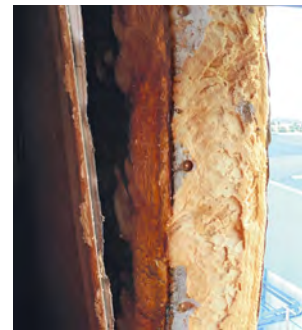
Window removed by Fire Service to ventilate the building to gain access – no fire penetration of core material.

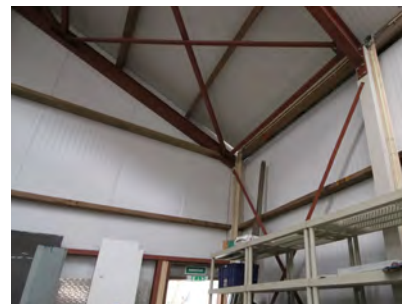
No heat transfer damage to interior of adjacent property (building A).

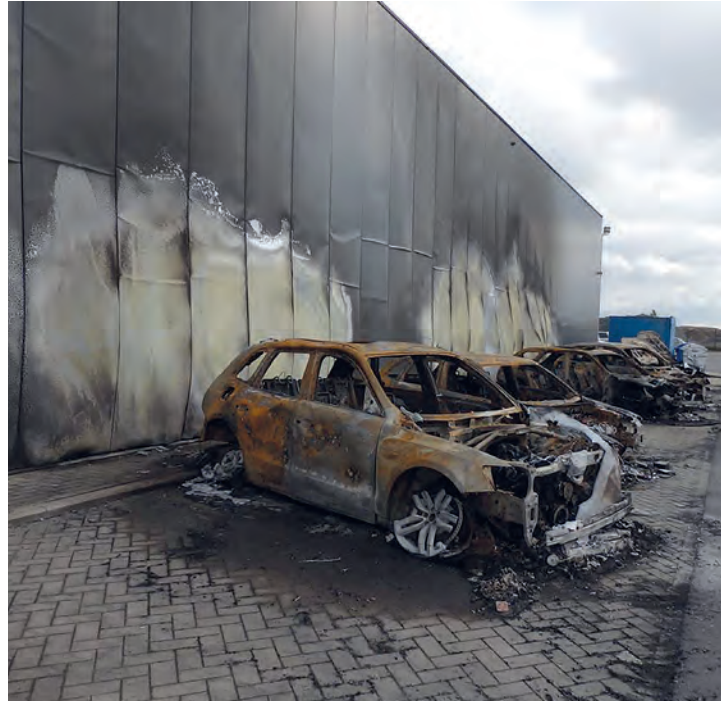
Photograph 1 shows the aftermath of the fire and is a photograph taken (by others) shortly after the fire event. The car in the foreground is understood to be an Audi Q3 with other cars being of at least a similar make and model.

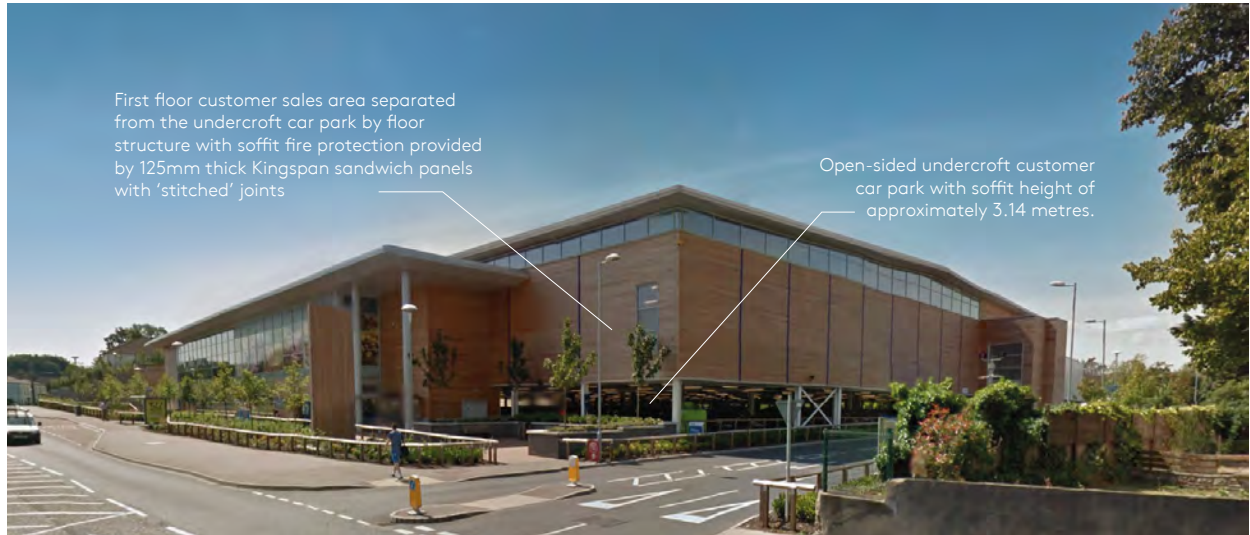
The main image shows the front elevation of the building from the main road and the corner of the building that was closest to the fire location. The overall footprint area of the building is approximately 11,500m² with the ground level undercroft car park occupying a slightly smaller footprint of approximately 11,200m² due to the ground level entrance foyer at the front of the building, which forms part of the same compartment as the sales area above. The majority of the car park possesses a flat soffit at 3.14m above floor level that has been created by the installation of 125mm thick Kingspan KS1100 CS FM approved PIR core sandwich panel.
