TEST REPORT No. 15/02

Performance tests on cavity cladding façade mock-up for Mainfreight Building, Hamilton, in accordance with the method of AS/NZS 4284: 2008 Testing of Building Facades, excluding the deflection test.

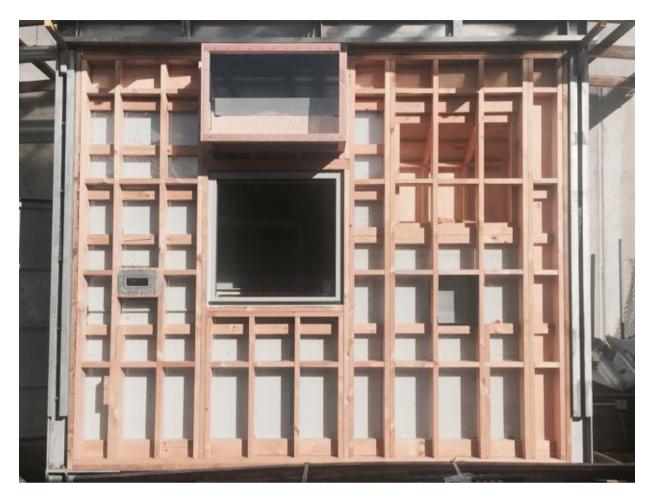
The test sample included; a parapet, internal and external corners, simulated meterbox, scupper, soffit junctions, top and bottom plate and all window junctions.

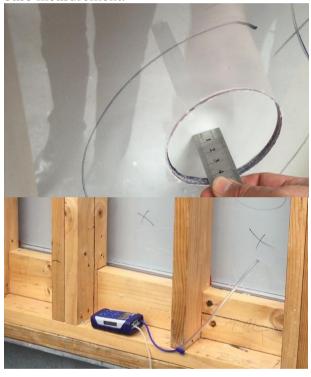
No damage or collapse was observed.

The panel was found to deflect by approximately 10 mm in either direction from a 50 mm base measurement.
