TEST REPORT

**SLIP RESISTANCE CLASSIFICATION OF
NEW PEDESTRIAN SURFACE MATERIALS
AS/NZS.4586:2004**

Forte Flooring

Ultra, Timber Flooring

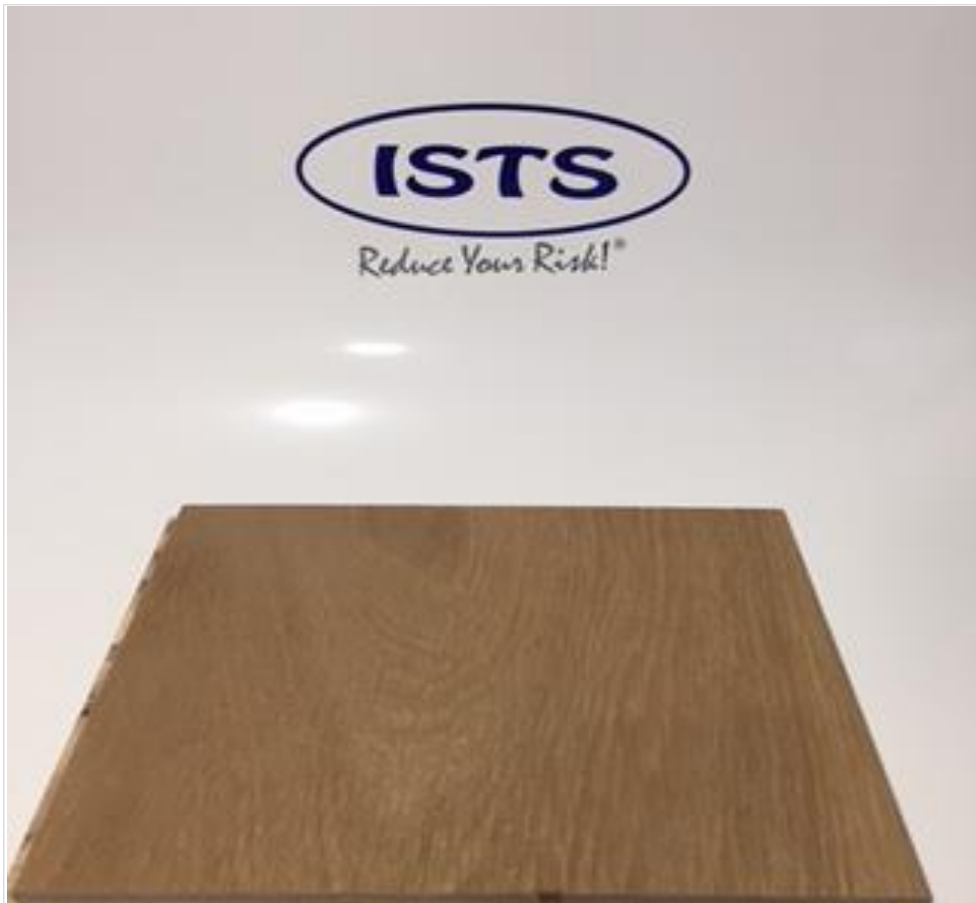
TEST PRODUCT IMAGE

Product Description: Ultra, Timber Flooring
