Multi-Unit Residential

Inter-Tenancy Wall and Floor/Ceiling Systems and their Junctions

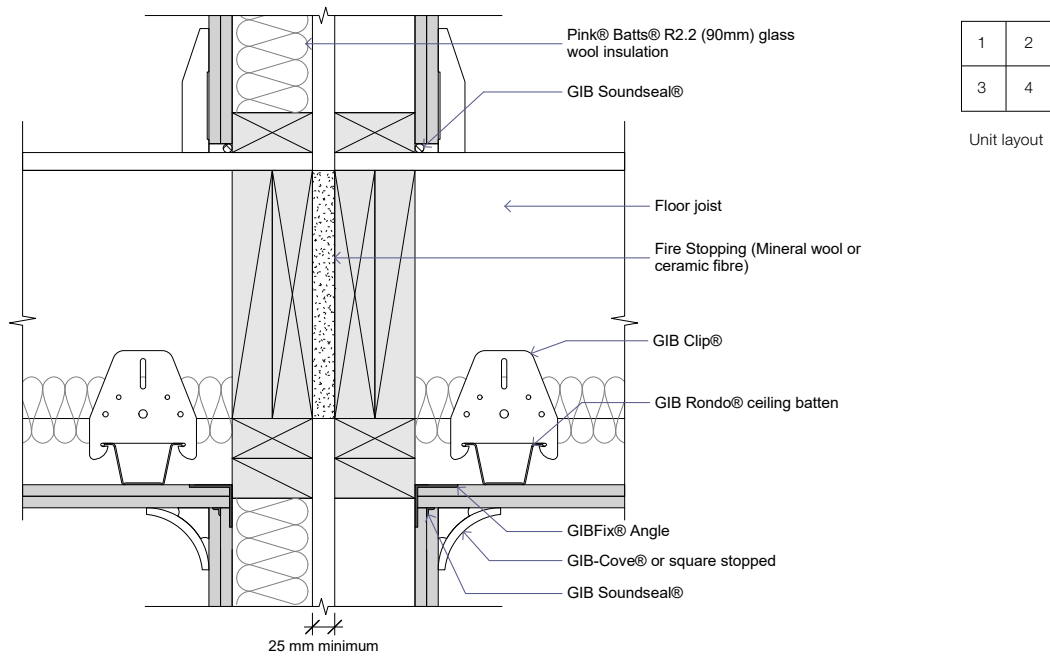
FIGURE 3: Typical IT double timber frame wall and floor/ceiling junction

Figure 3 illustrates a junction where IT wall and floor/ceiling systems meet, separating four apartment units.

All service penetrations through the wall and ceiling linings must be fire-stopped to ensure fire is contained within an affected apartment. The mass of the ceiling linings and lower apartment wall linings also assists with achieving required noise attenuation between levels and minimising potential impact and airborne noise ‘flanking’ via the structure.

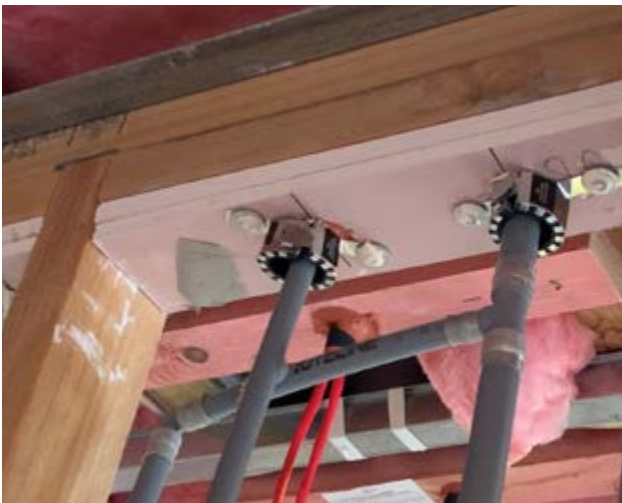
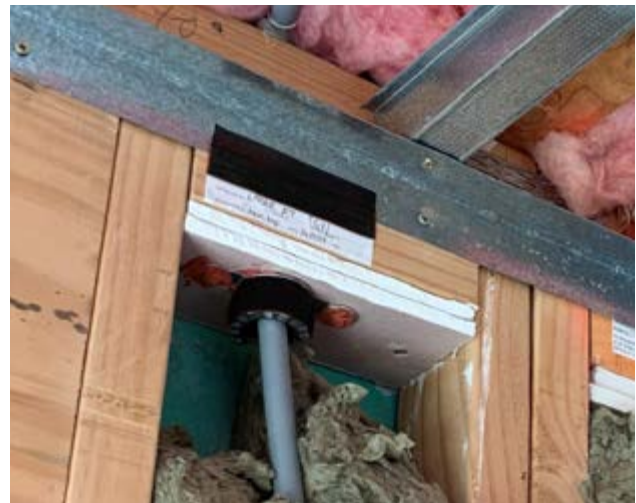
FIGURE 12: Proprietary Penetration Seals where Services pass through the Top Plate
Examples of services fire-stopped using tested systems installed below the double top plate

As illustrated in Figure 12 penetration seals are installed where services pass through the top plate. Follow the instructions provided by the penetration seal supplier. Service holes are drilled centrally through the timber top plates leaving a minimum 20 mm of timber each side.

Unless fire-stopped, no wall lining service penetrations are permitted above the highest nog. Below this level wall lining penetrations do not need to be fire-stopped.
